RADIATION SAFETY ISSUES ASSOCIATED WITH OPERATING AND MAINTAINING INTENSE BEAM ACCELERATORS

Tom Noone, Assistant Duty Officer
Rutherford Appleton Laboratory, Chilton, Didcot, U.K

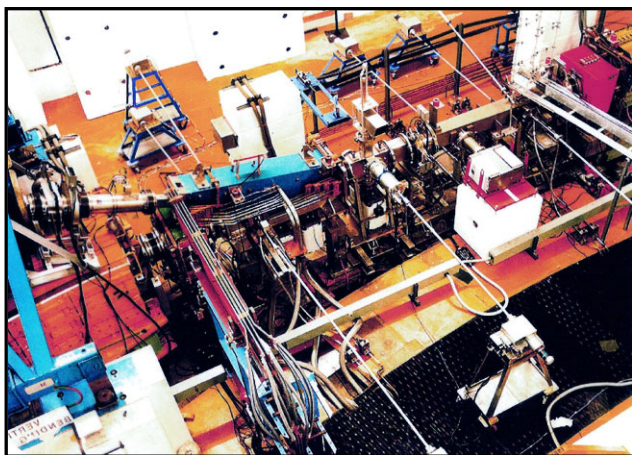
Figure 1, Straight 1 Prior to decommissioning

Extract septum cooling circuits and bus bar failures, failed vacuum ion pumps, high prompt beam loss downstream of the collector system giving probable cause for observed beam loss on the R.F. screen of dipole 2.

A lack of purpose built shielding severely restricted general access making modifications and replacement of existing failed components hazardous to personnel.

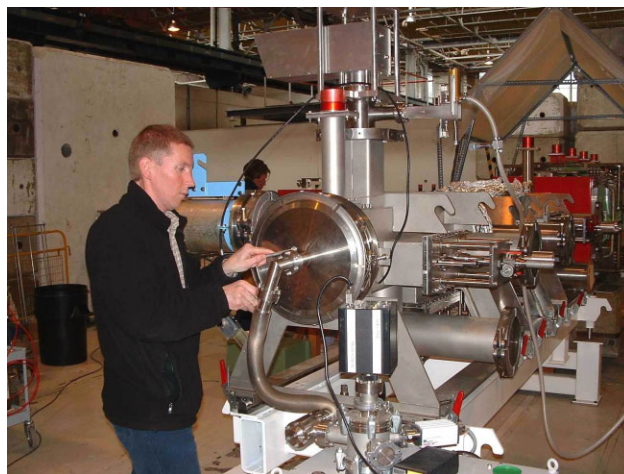
Figure 2 Pre-build area

The project team identified one approach to minimising the installation time exposure would be by Pre-building the new straight 1 in a dedicated clean area (see figure 2). This allowed for the build, alignment and testing of the modules and components thus eliminating any problems that may have otherwise been discovered only at the time of installation in the ring.

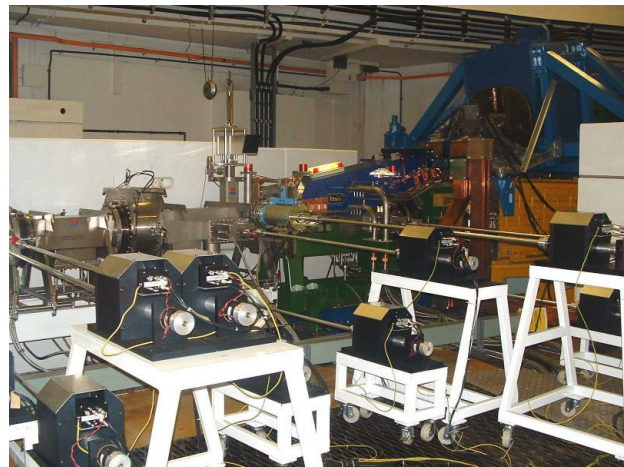
Figure 3 View of the new straight 1

Once the major components had been connected new concrete shielding blocks were fitted into place. (figure 3) These now provide good protection from radiation for personnel working in this area of the machine. Vacuum pumps and where possible collector control systems are now mounted outside this shielding, allowing future component failures to be managed easily within the Radiation Regulations at ISIS. The entire project was carried out well within radiation dose limits. The estimated total collective dose of 5000 μSv given in the planning stage, was recorded as 3500 μSv at close of project. The highest individual recorded dose was 500 μSv . In summary by our Health Physicist, it was stated "The success of the decommissioning operation owes much to the planning and skill in execution of the Radiation safety Protocol, by all members of the team".
