High Risk Maintenance Project

at the LBNL 88-Inch Cyclotron

Jim Morel

April 15, 2010

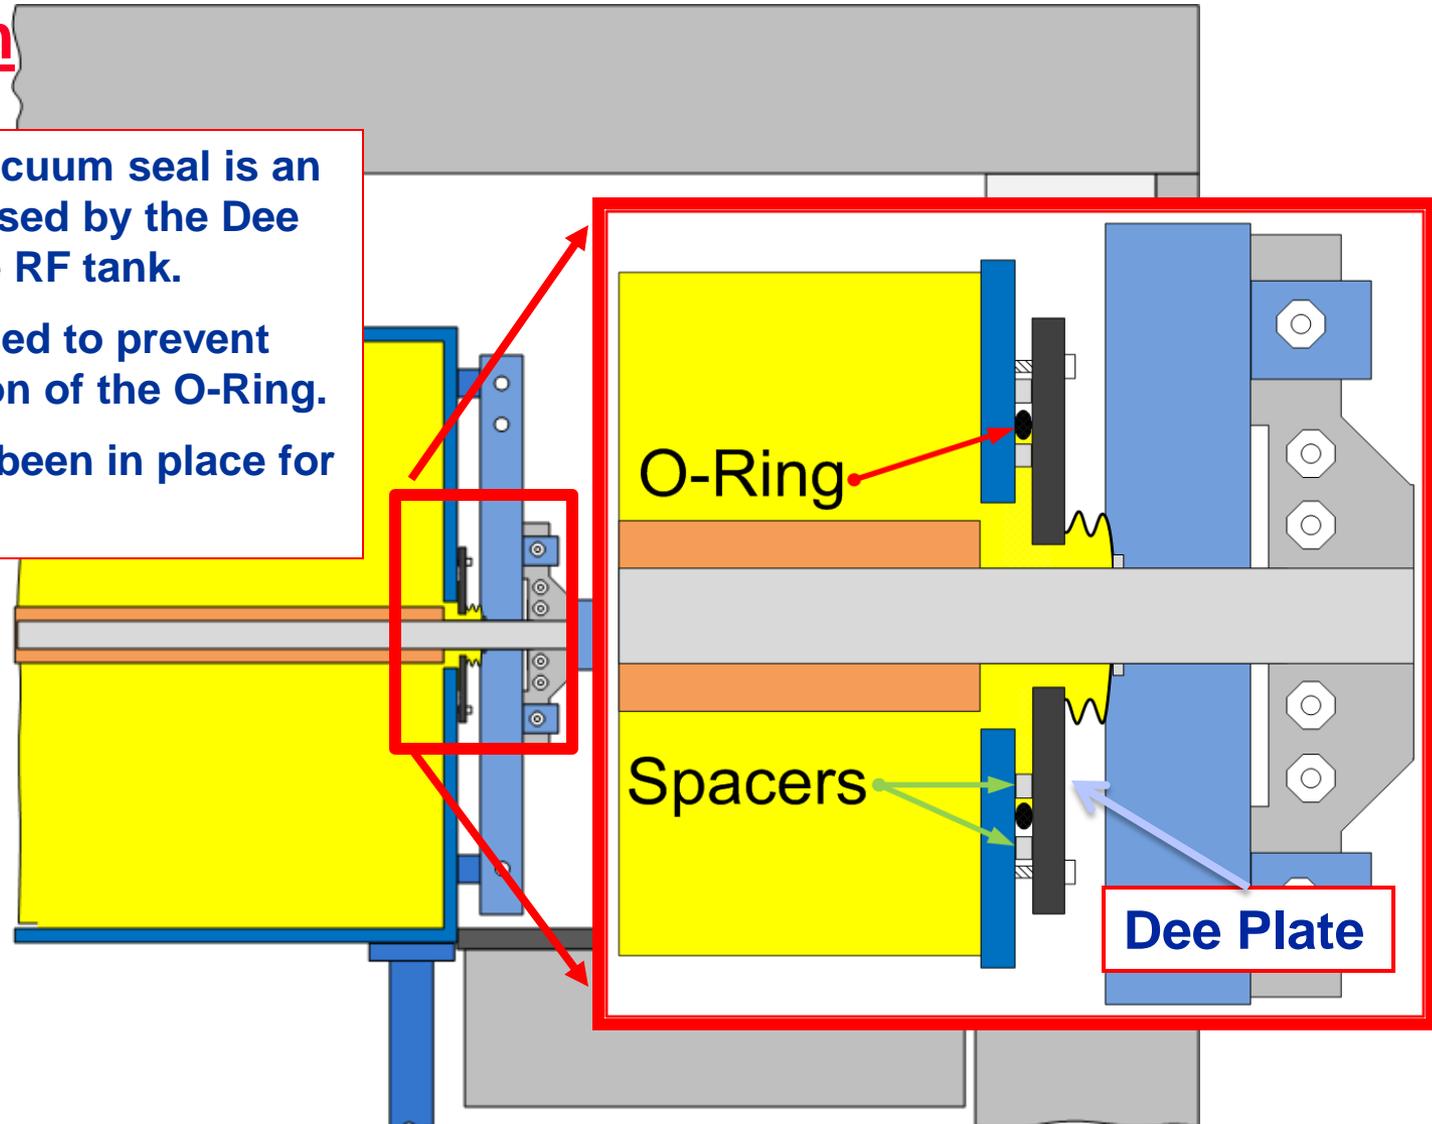
- The Dee plate vacuum seal is an O-Ring compressed by the Dee plate against the RF tank.
- Spacers were used to prevent over compression of the O-Ring.
- The O-Ring had been in place for over 30 years.

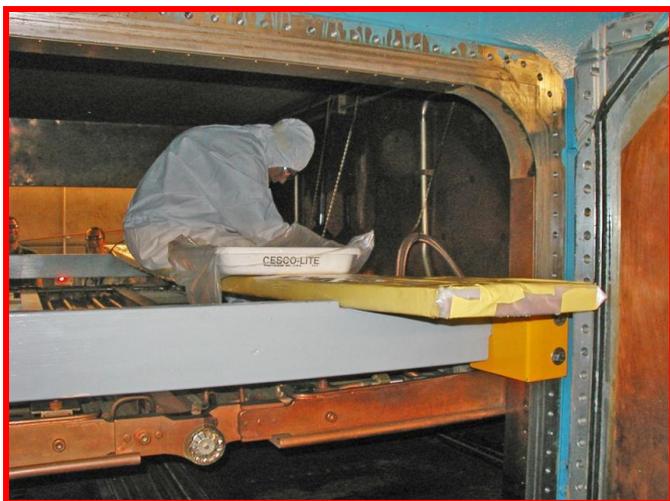
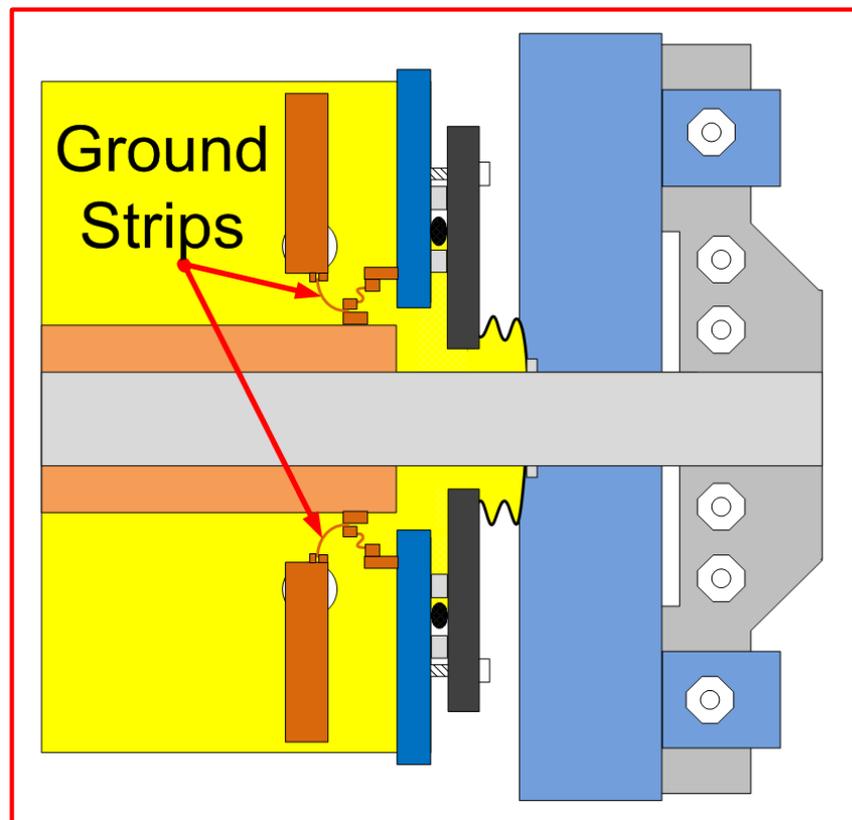
- Removing the Dee required removing the grounding strips between the Dee, RF panels and the RF Tank
- Removing the Dee grounding strips was risky.

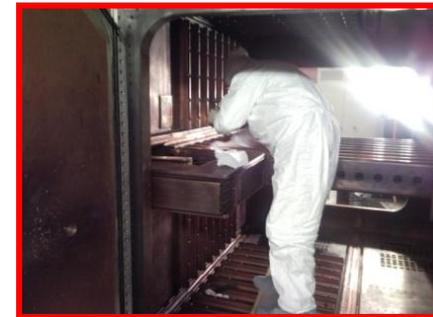
- The RF system had sparking problems and we had vacuum problems associated with high RF power.
 - We investigated and found the grounding strips had not remained attached and were overheated.
 - We also found a screwdriver had been left in the RF tank.
- The grounding strips were re-attached using appropriate material and the screwdriver was removed.
- Lesson Learned
 - How to attach the grounding strips.
 - We needed better management of tools.
