SLAC National Accelerator Lab.

# Recovery from the Fire Accident at PEFP

2012. 8. 9

Bum-Sik Park

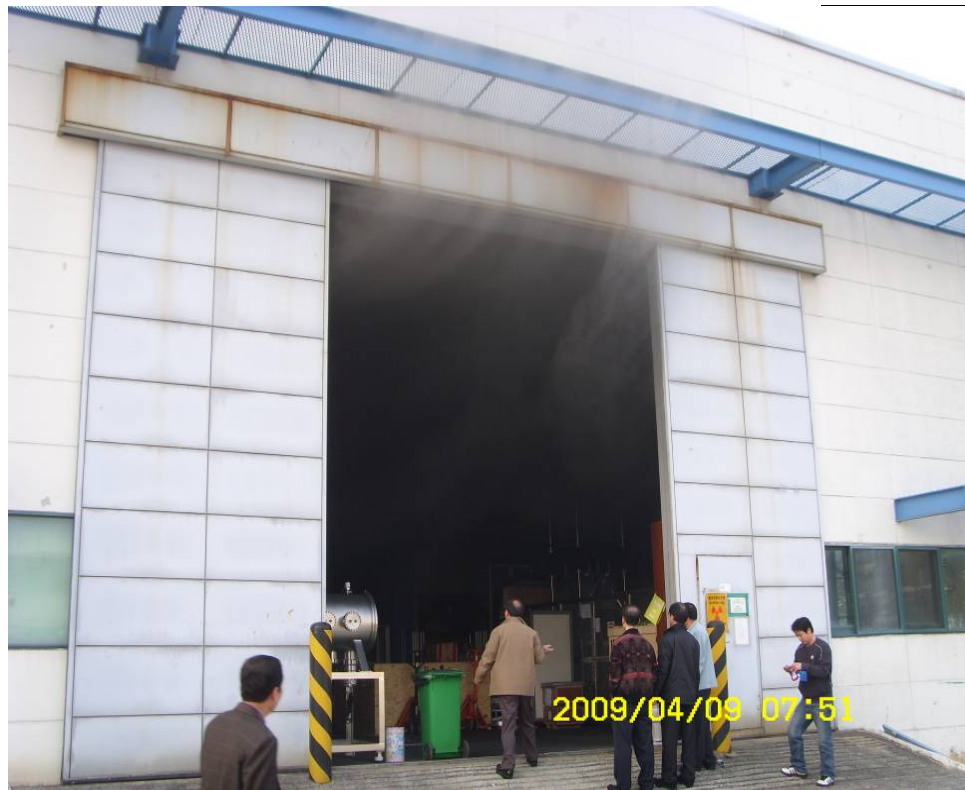
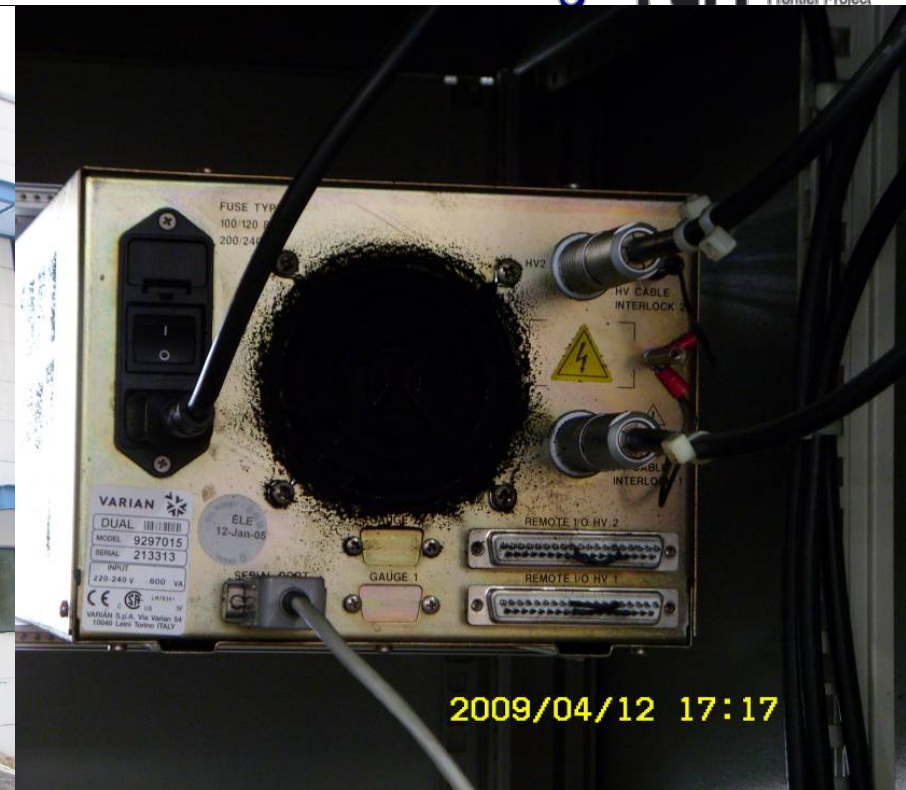
There was a fire accident

- : 9<sup>th</sup> April, 2009
- : A short circuit caused a fire in another lab.
- : The fire was got under control before the flame spread to 20MeV accelerator test room.

The 20MeV accelerator system was contaminated with carbon dust

- : Damaged not by flame but by the carbon dust
- : Electric power was cut OFF, Vacuum pump was ON, UPS was ON
- : Access was permitted after one hour later.

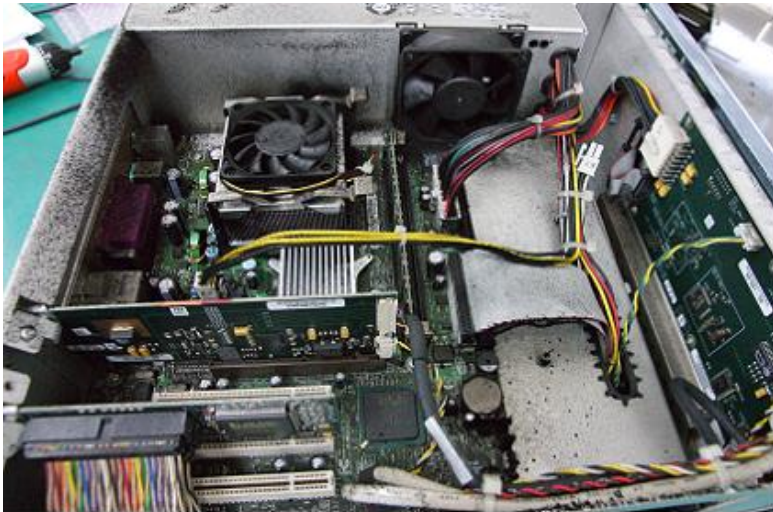
Oscilloscope

Fans of the RF and measurement equipment were operating during the fire accident because of UPS

- Equipment were contaminated with sticky carbon dust.
  - RF system : RF signal generator, network analyzer, oscilloscope
  - Measurement equipment : Electrometer, DAQ(PXI)
- => Repurchased through the manufacturer's opinion.

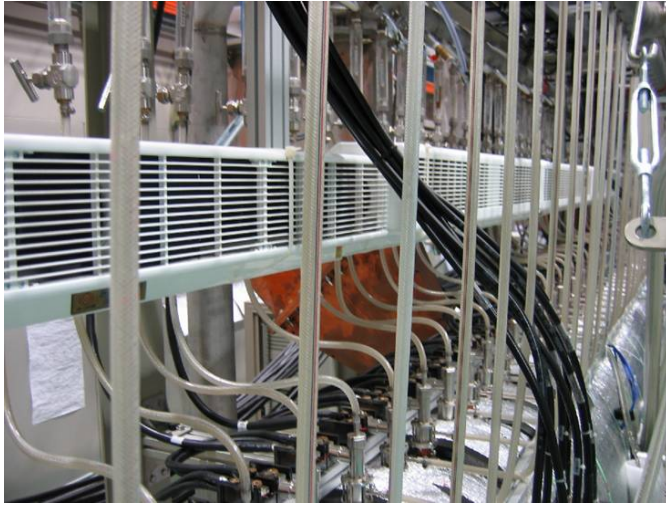
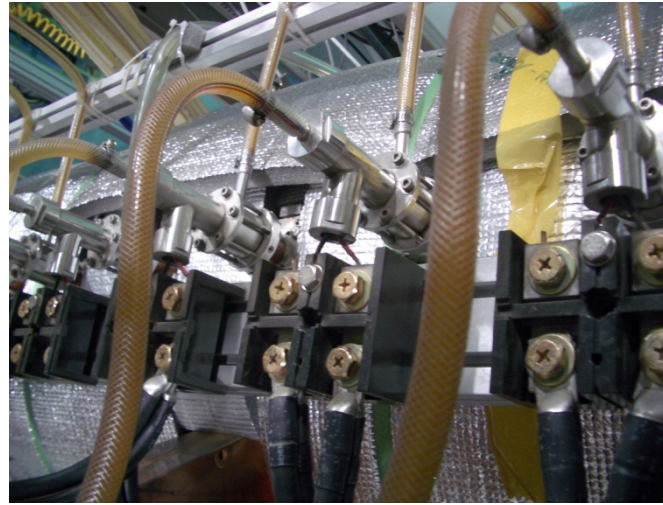
Air shower and  
general terminal  
block

- QM current lead (Power loss 800 W/QM)
  - Old one : Forced air cooling (Temperature at current lead ~ 100 deg. C)
  - Revised one : Water cooling (Temperature at current lead ~ 80 deg. C)

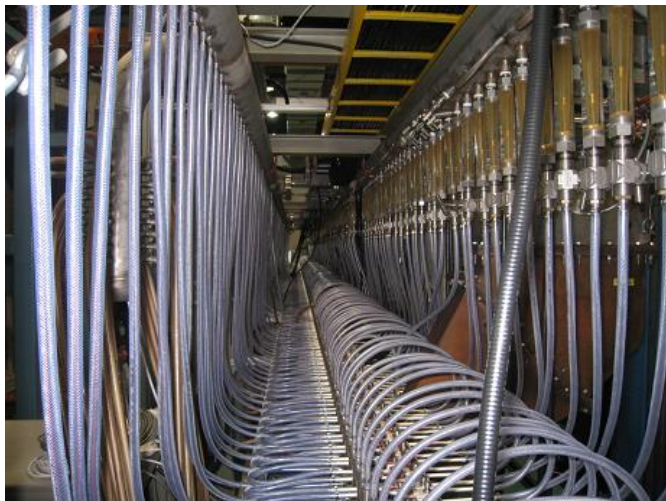
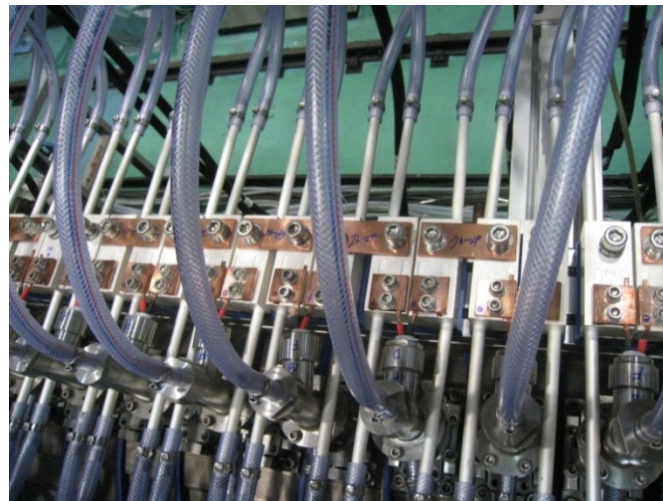
Water cooled  
terminal block
