Current Status of Refurbished Target Irradiation System for Radioactive Isotope Production Using an Electron Linear Accelerator at Research Center for Electron Photon Science, Tohoku University

Presentation ID : PO28

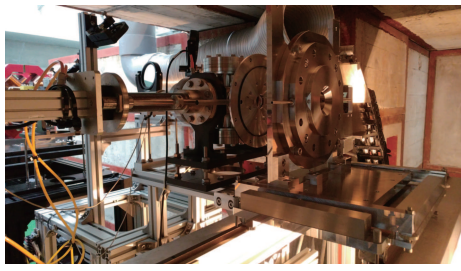
Enclosure of bremsstrahlung converter is now detachable and can be move over the rail.
