Study of Electrical Noise Induced by Synchrotron Radiation

JASRI/SPring-8

Problem: unstable X-ray intensity

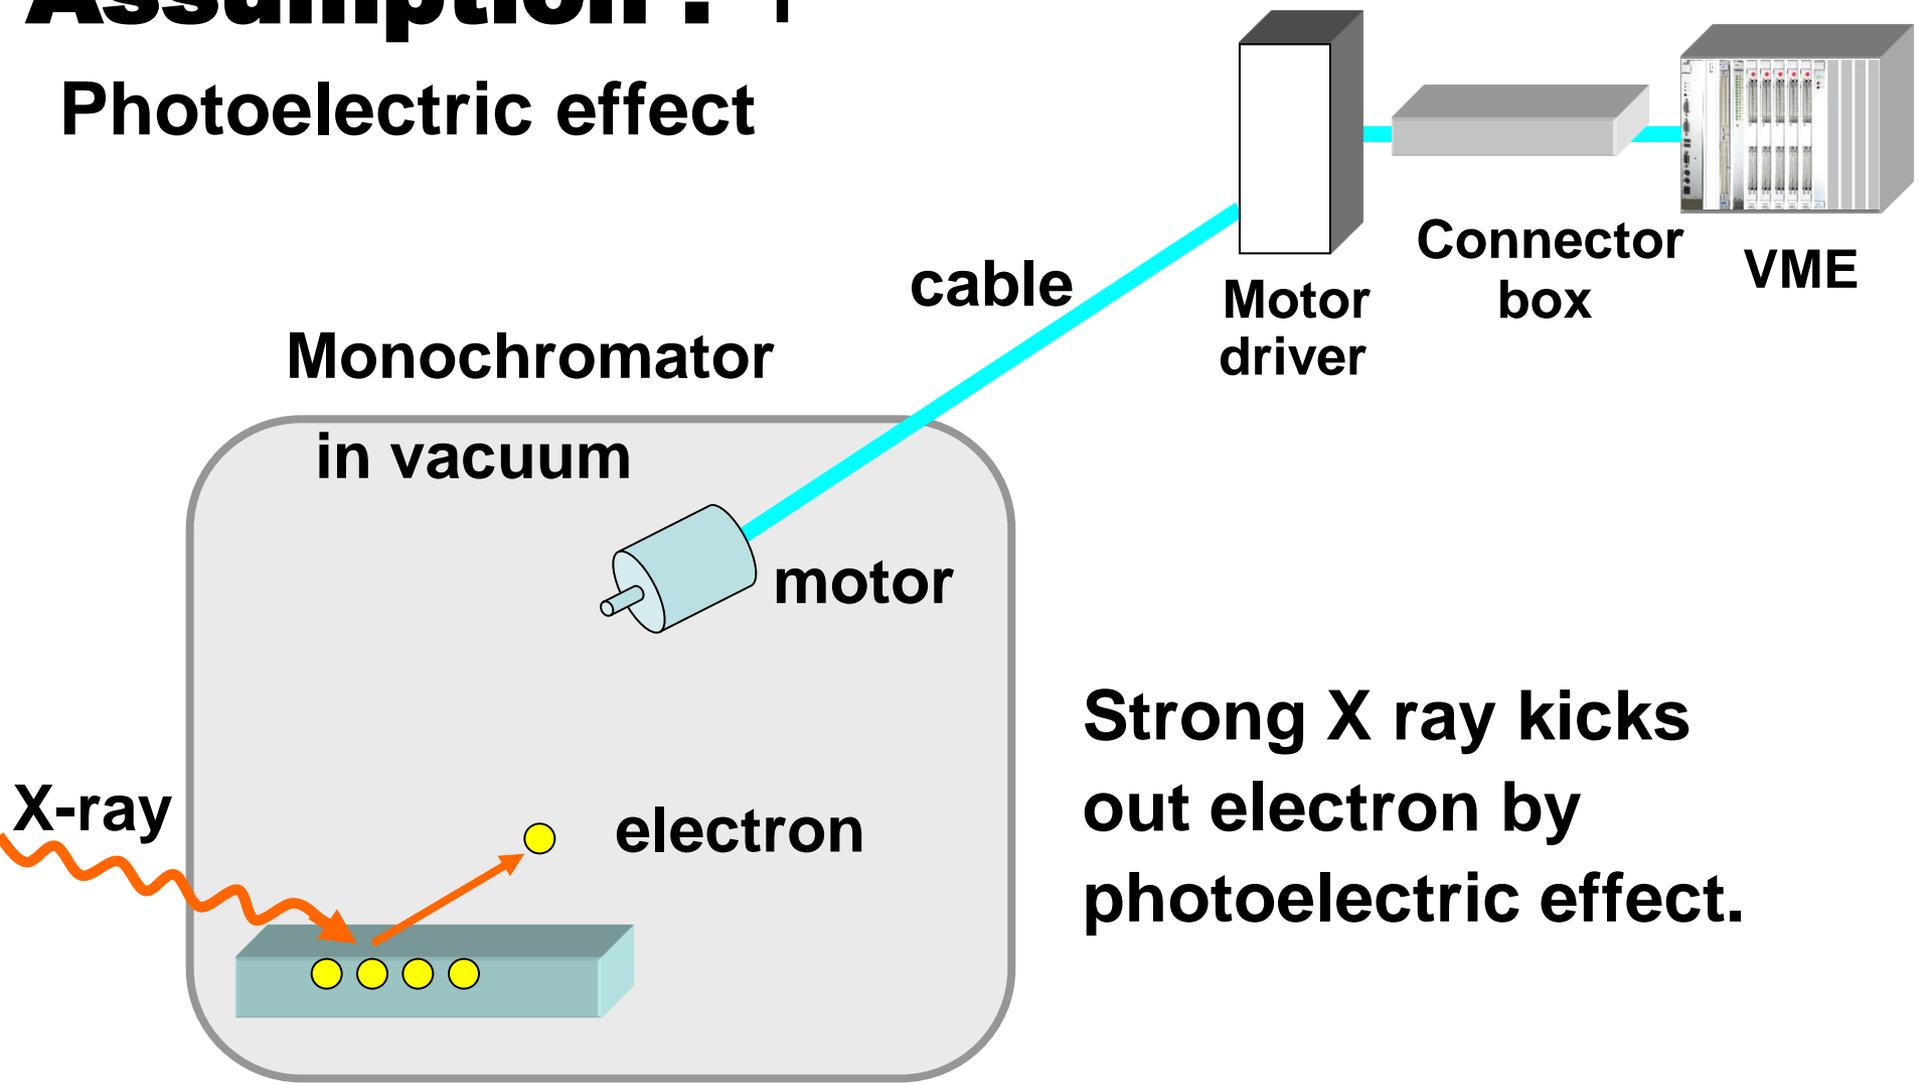
Assumption : 1

Photoelectric effect

Strong X ray kicks out electron by photoelectric effect.

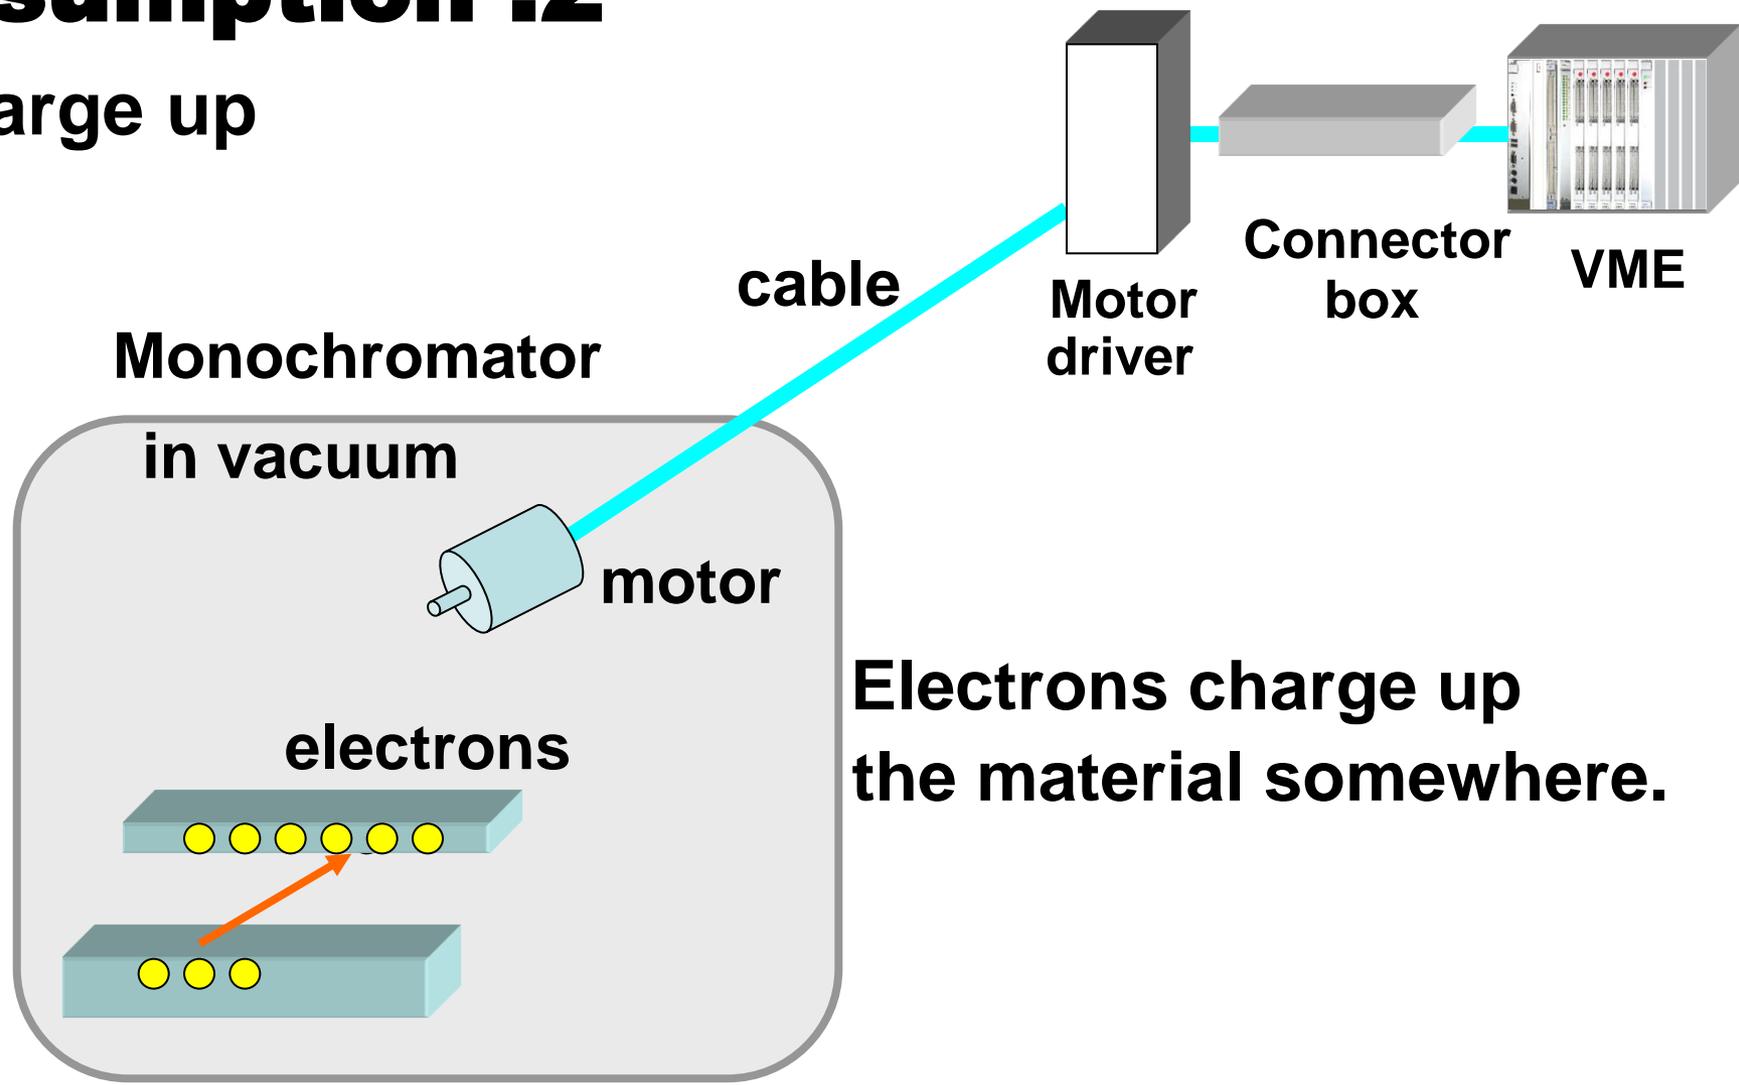
Assumption :2

Charge up

Electrons charge up the material somewhere.

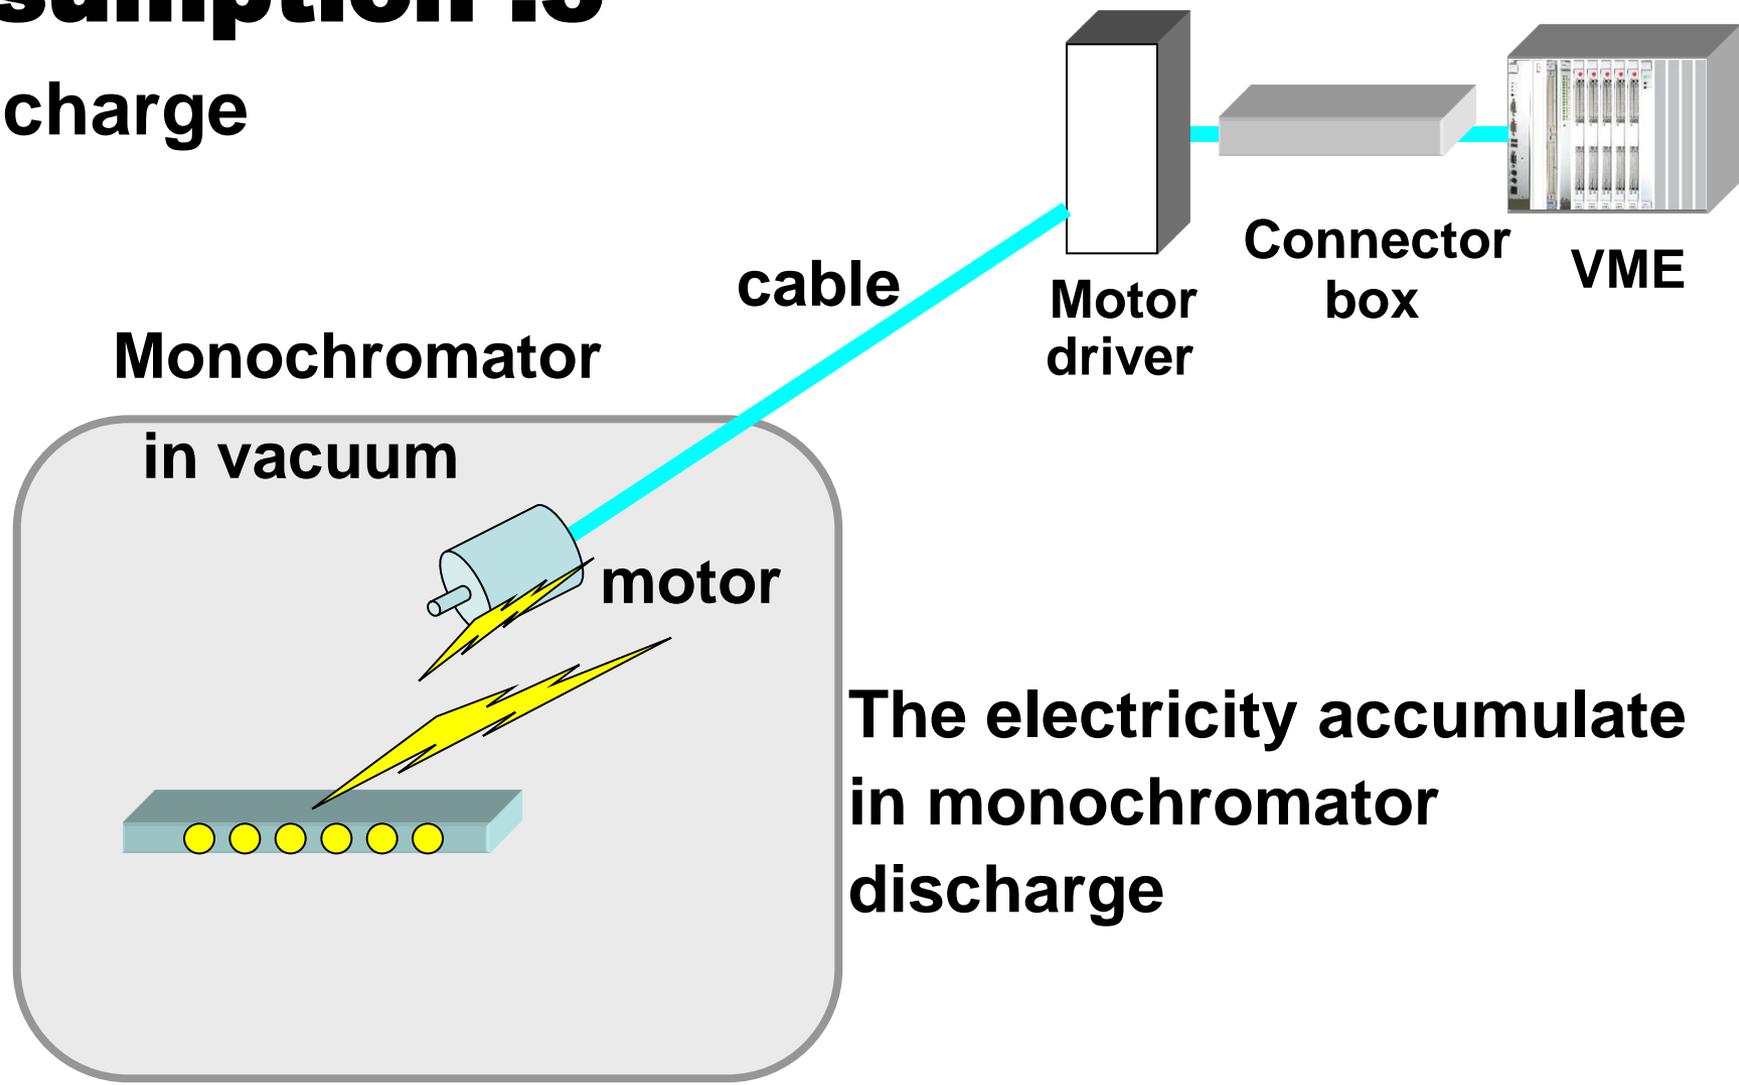
Assumption :3

Discharge

The electricity accumulate in monochromator discharge

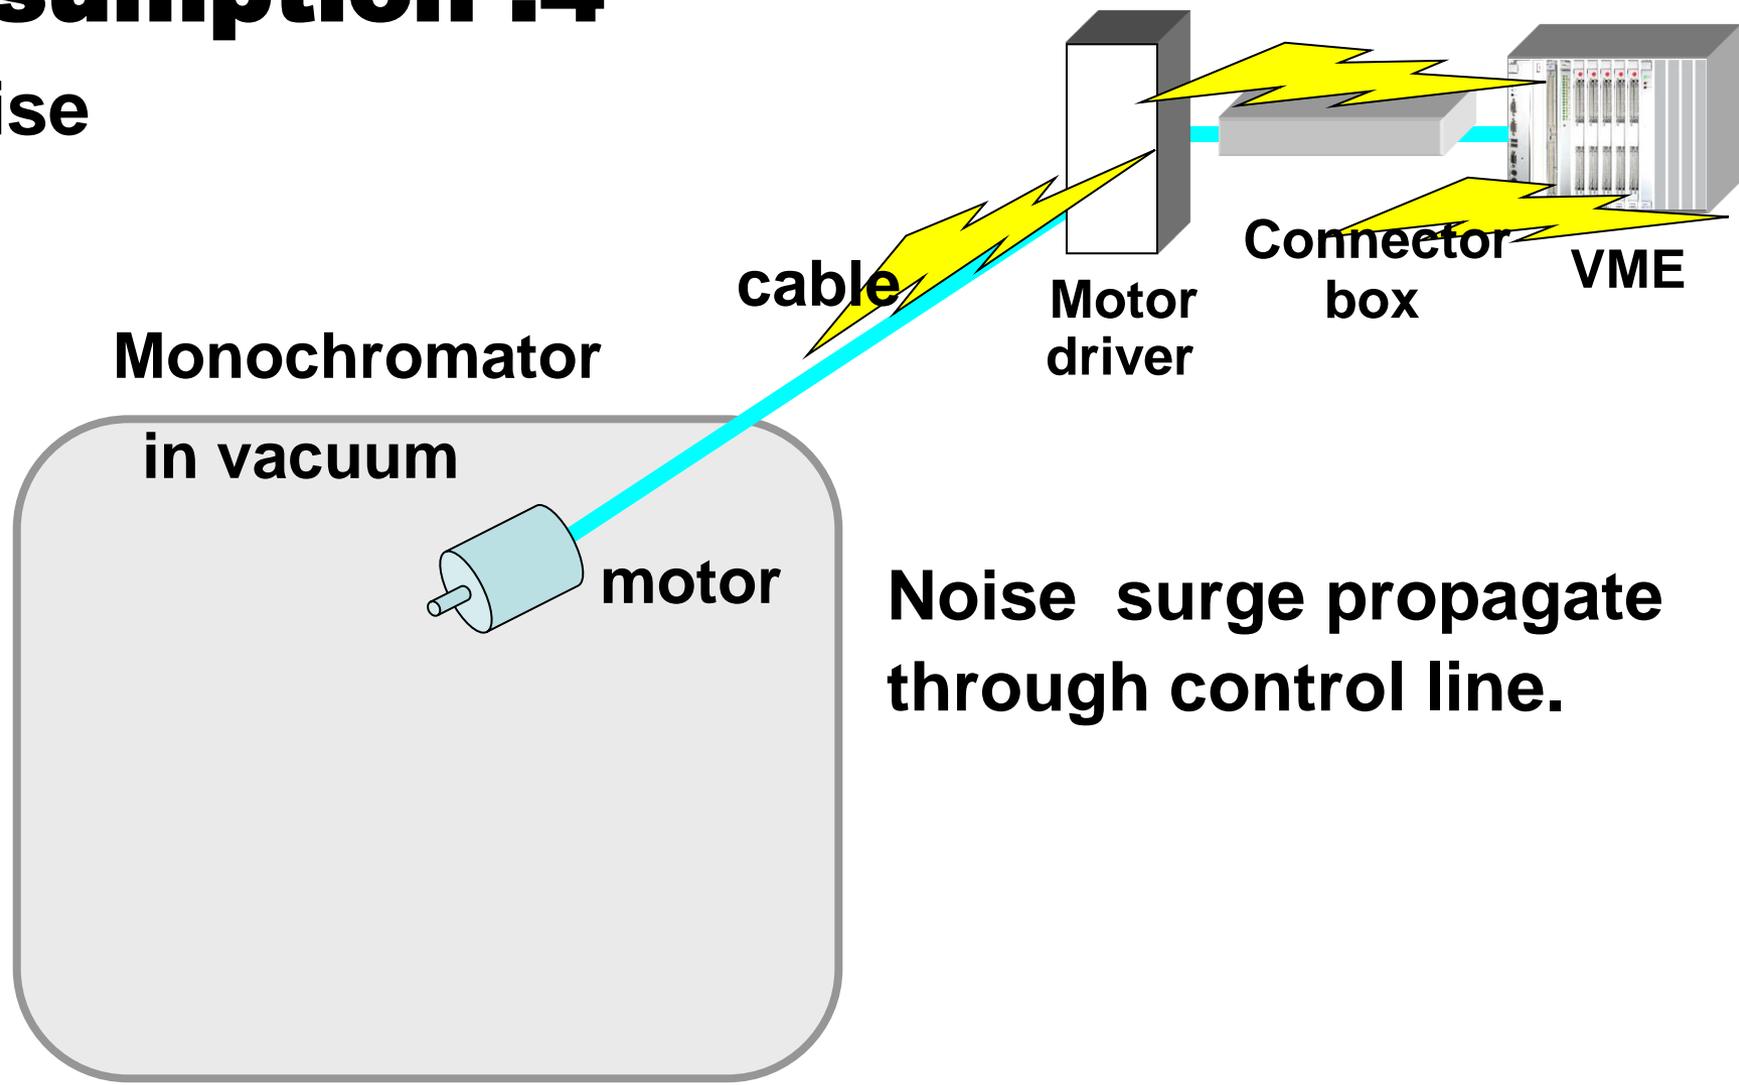
Assumption :4

Noise

Noise surge propagate through control line.

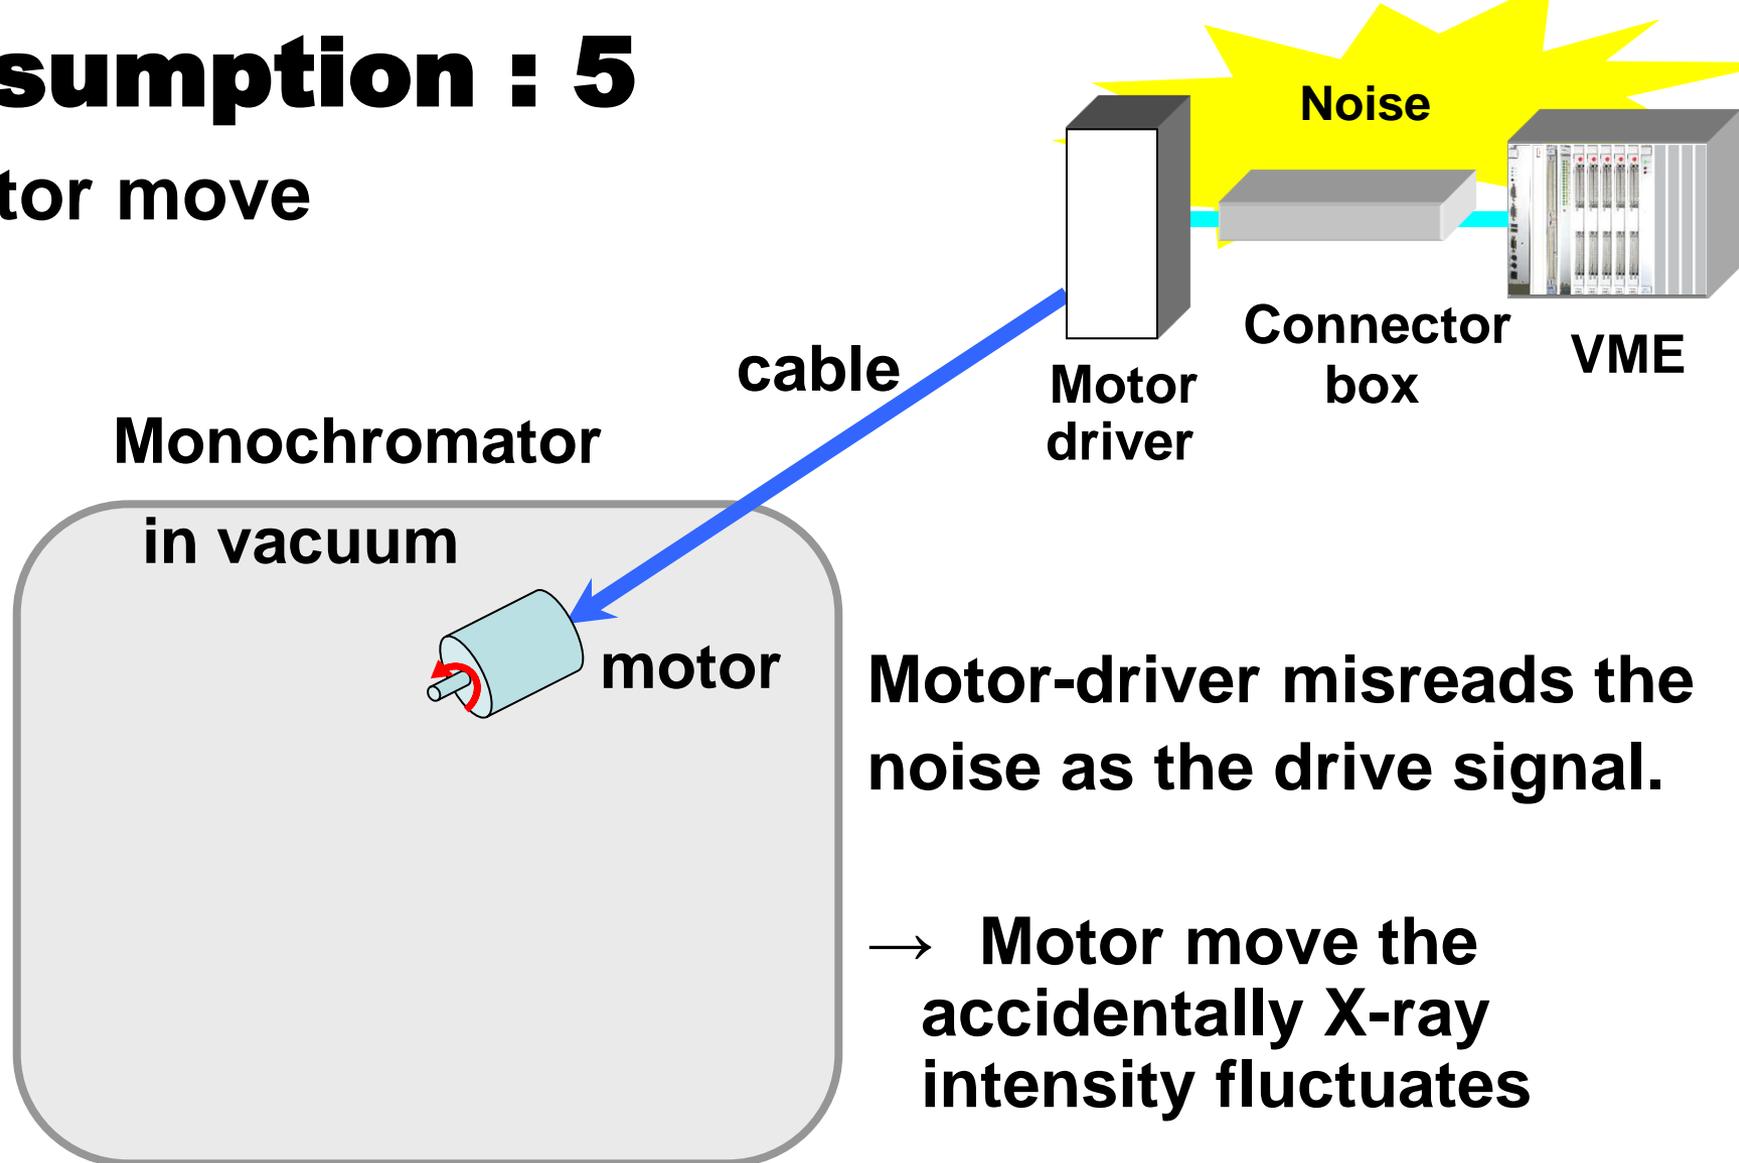
Assumption : 5

Motor move

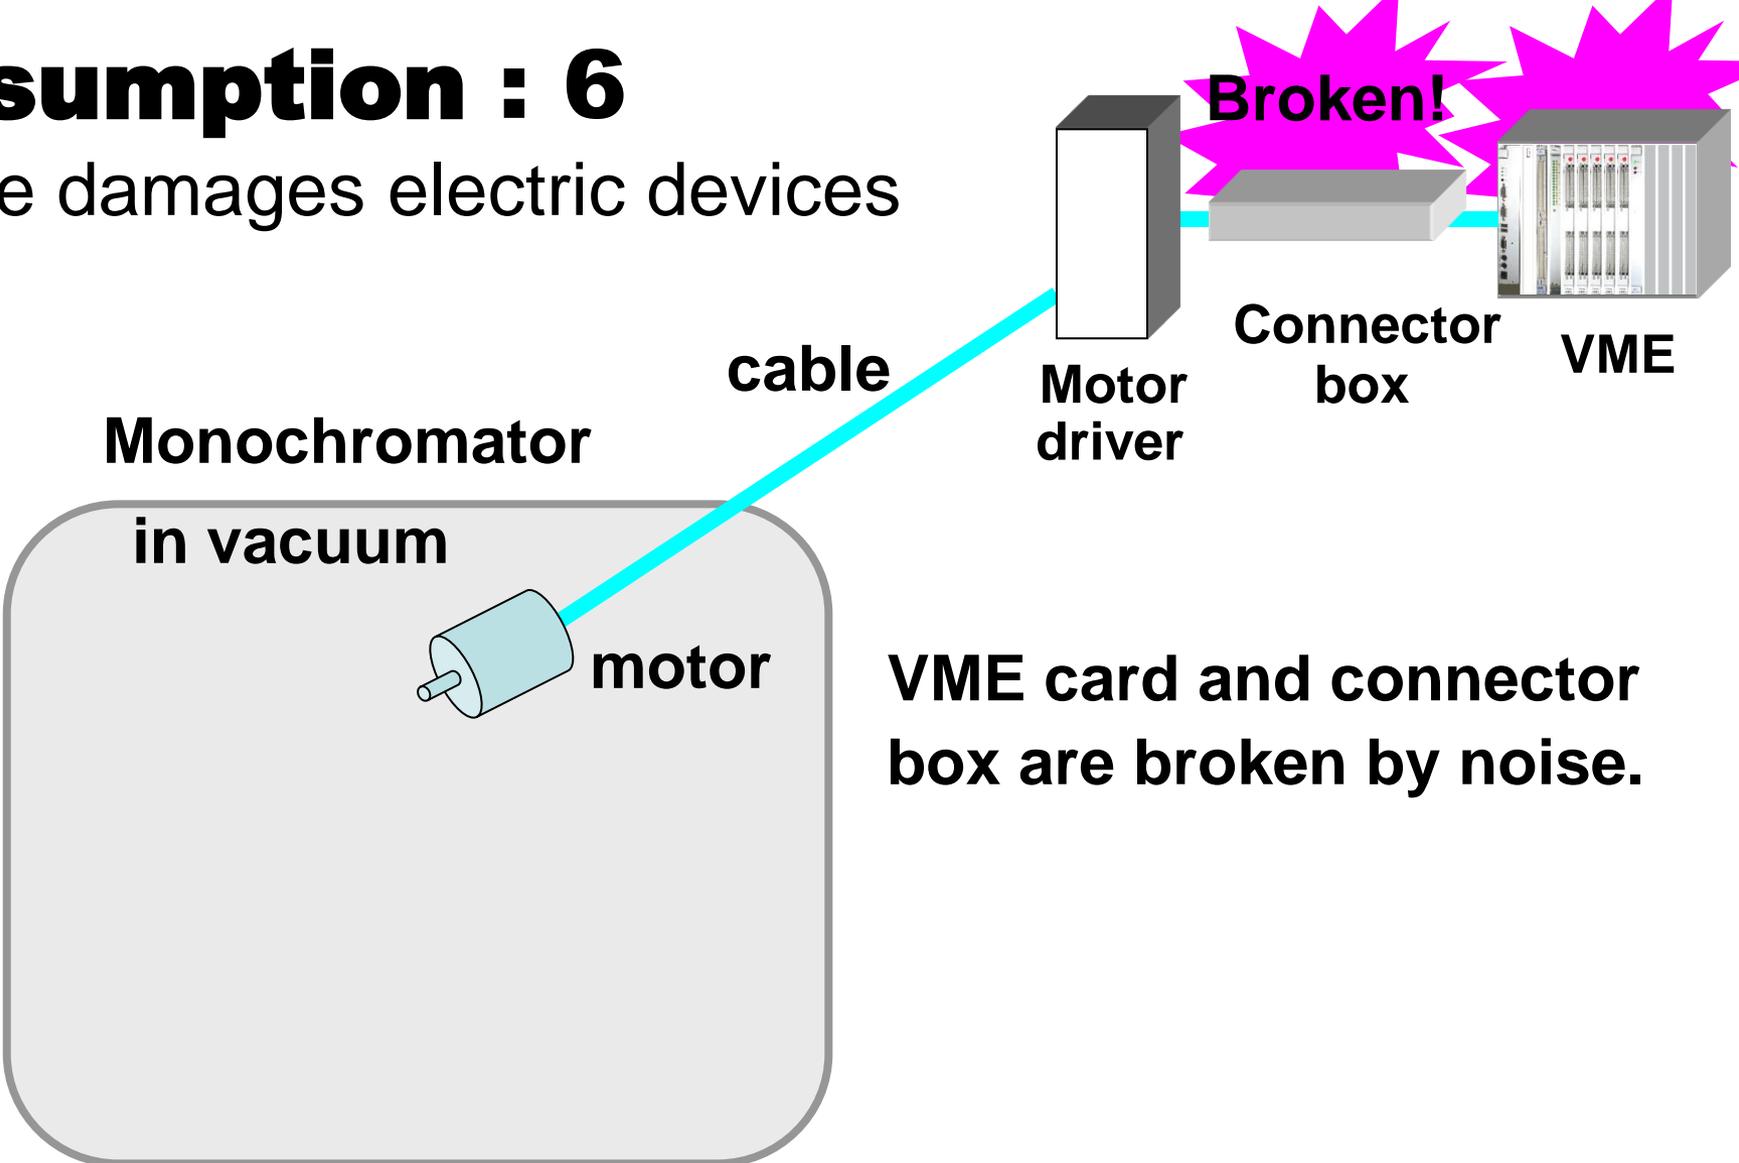
Assumption : 6

Noise damages electric devices

Broken!

VME card and connector box are broken by noise.

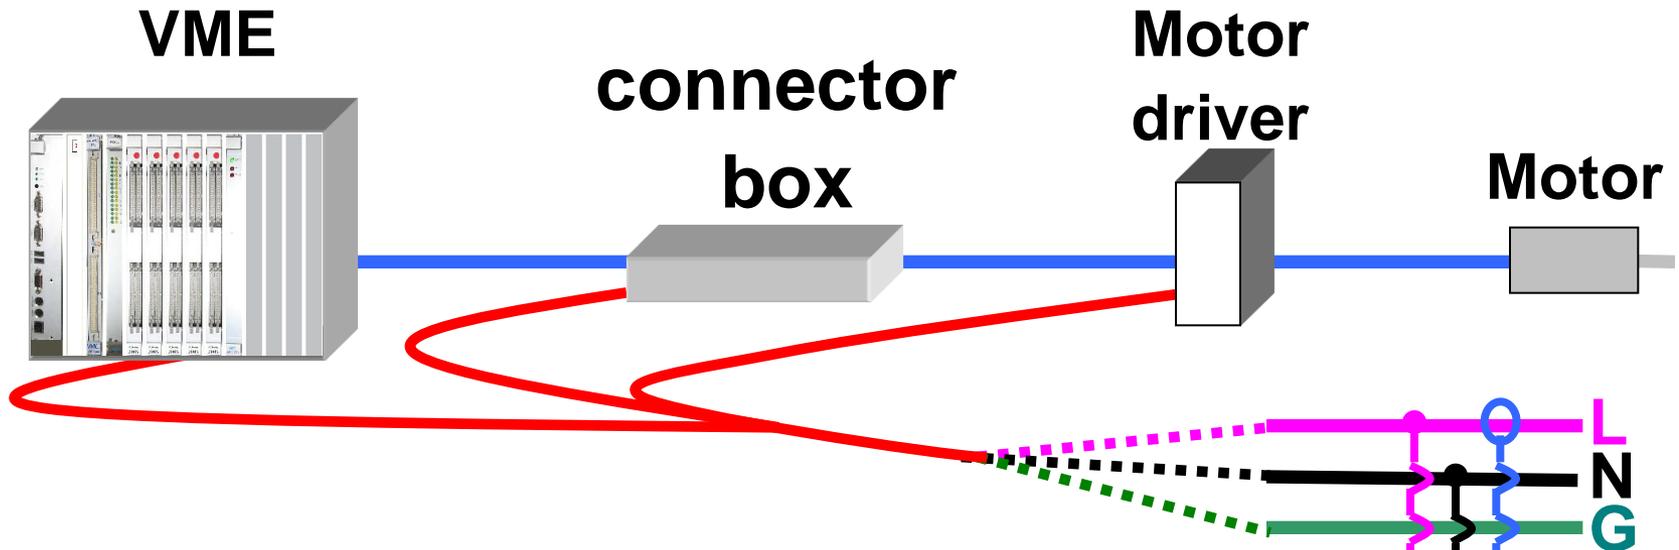
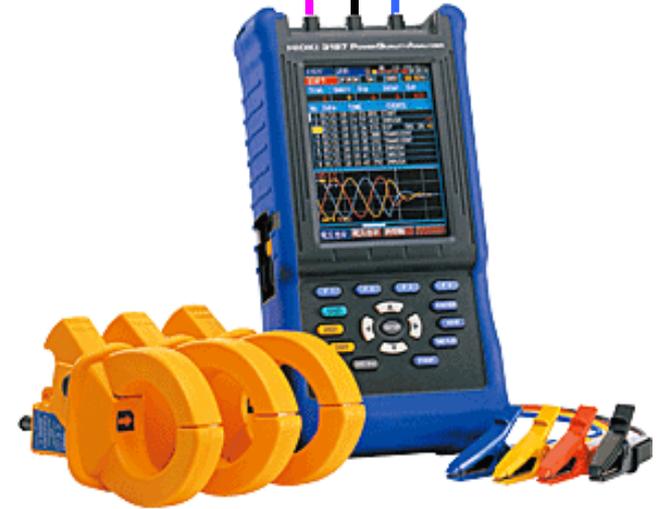
AC Power quality analyzer

Power quality analyzer 3197

measurement instrument to monitor and analyze

- AC voltage
- Frequency
- Waveform
- Current value
- Harmonic
- etc,

I find power line no problem.

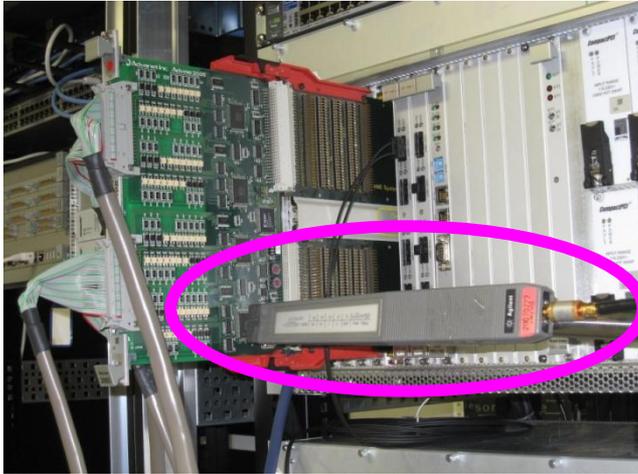
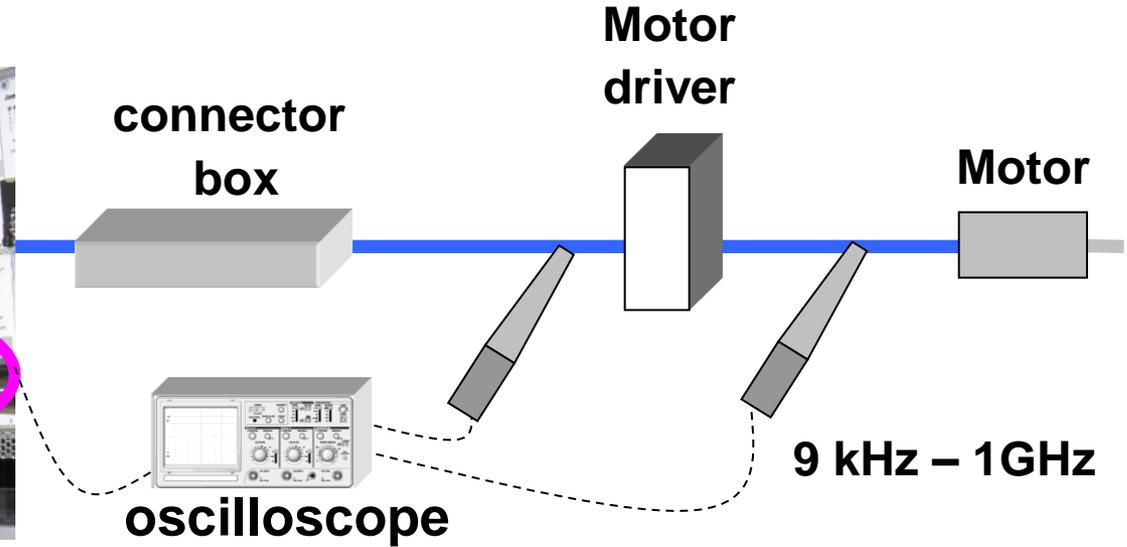
Magnetic near-field probe

Joint slot for the maintenance

11941A Close Field Probe

measures magnetic field radiation from surface currents, slots, cable.

Quantitative measurement difficult.

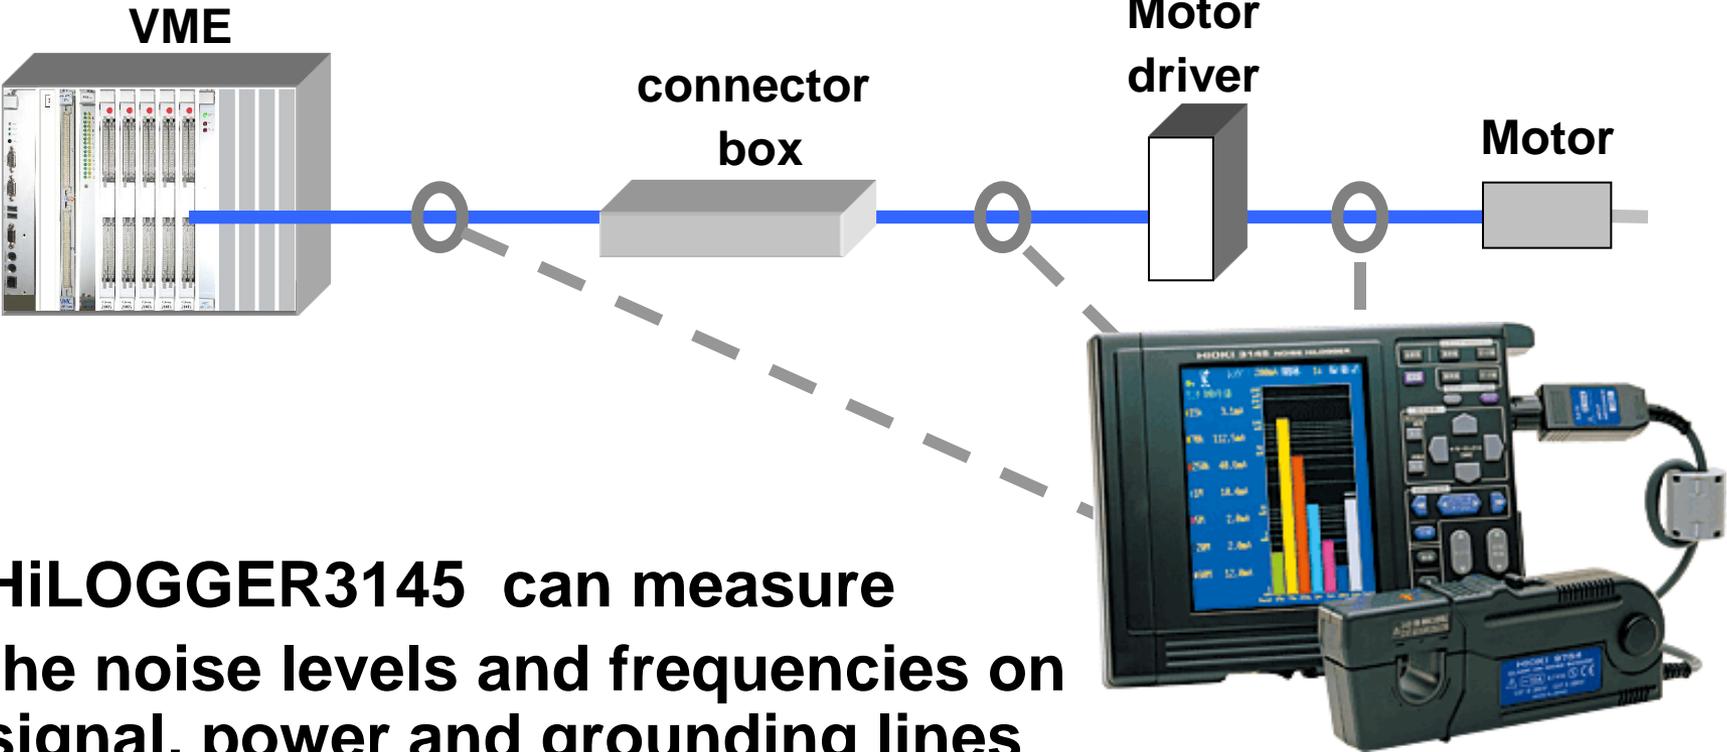
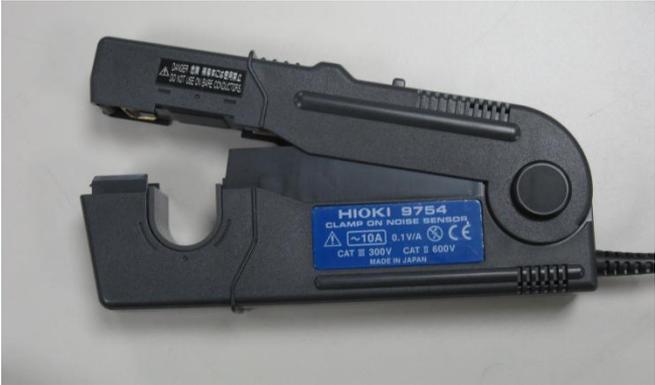
CLAMP ON NOISE SENSOR

HiLOGGER3145 can measure the noise levels and frequencies on signal, power and grounding lines connected to electronic devices.

Noise sensor 9754

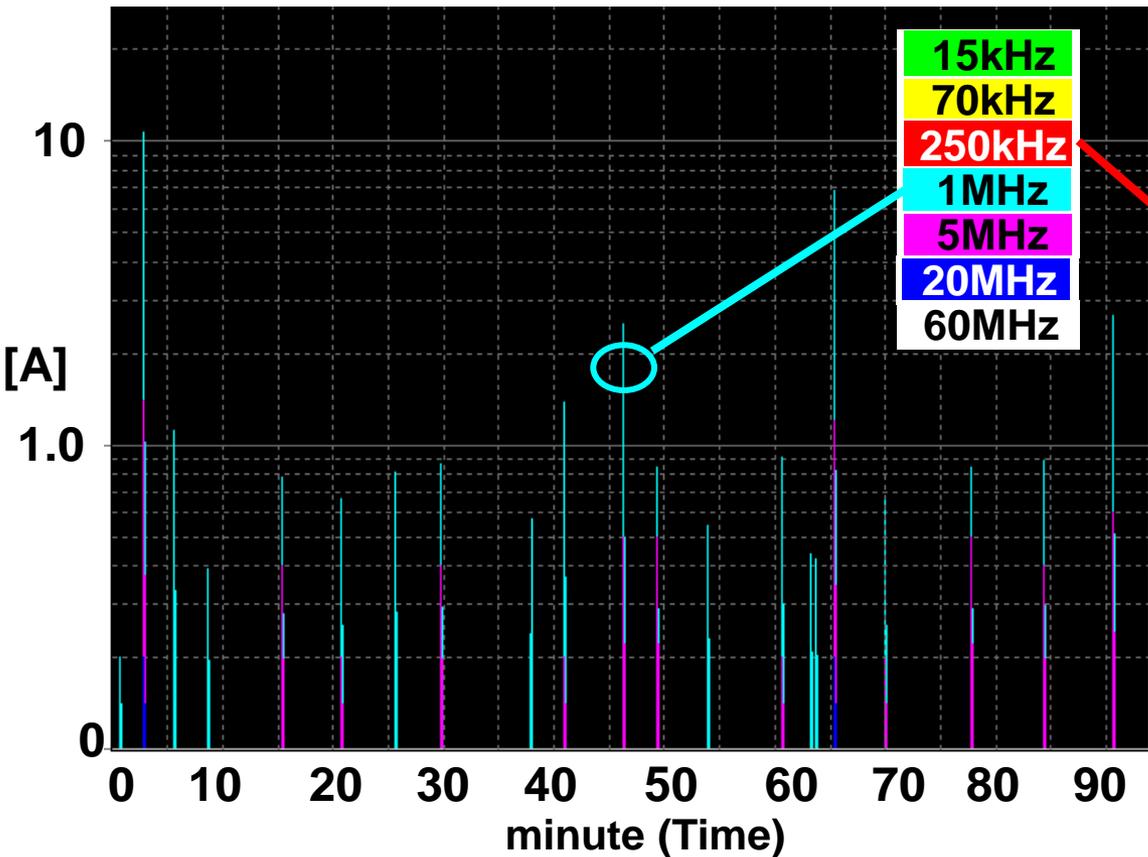
CLAMP ON NOISE SENSOR

Display real-time peak-to-peak value in 7 frequency band on level meters.

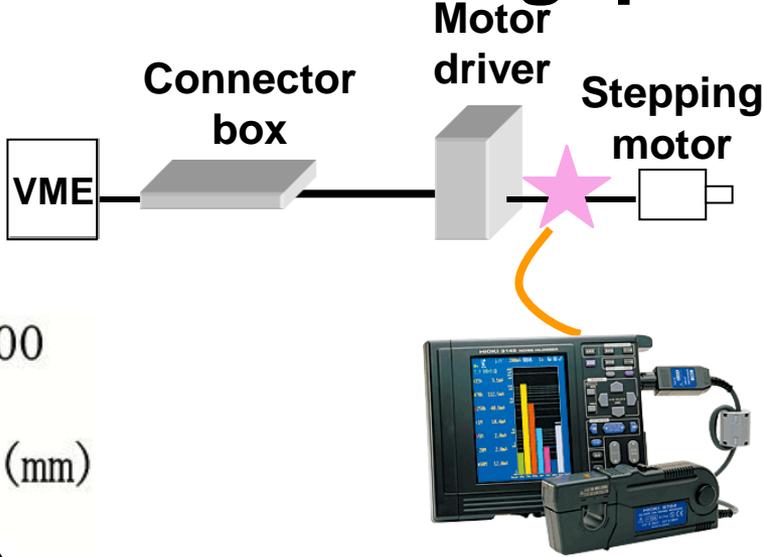
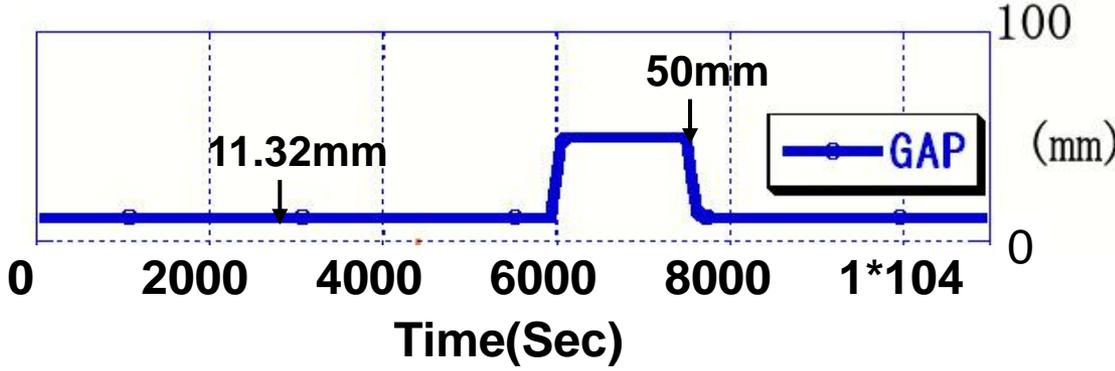
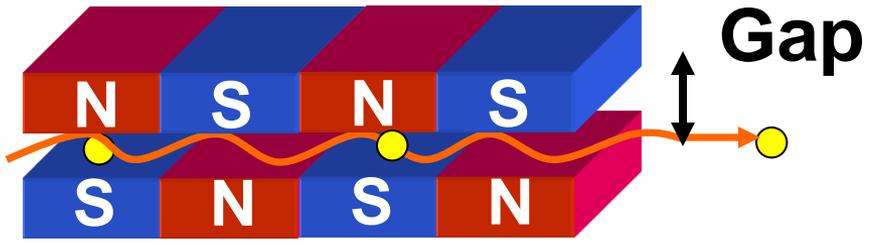
Correlation between noise and undulator gap

Undulator

Gap open → Low flux
Gap close → High flux

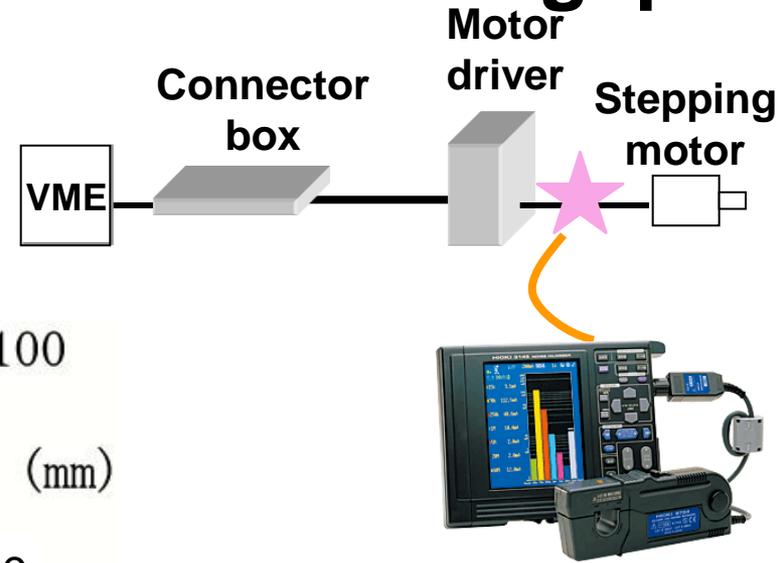
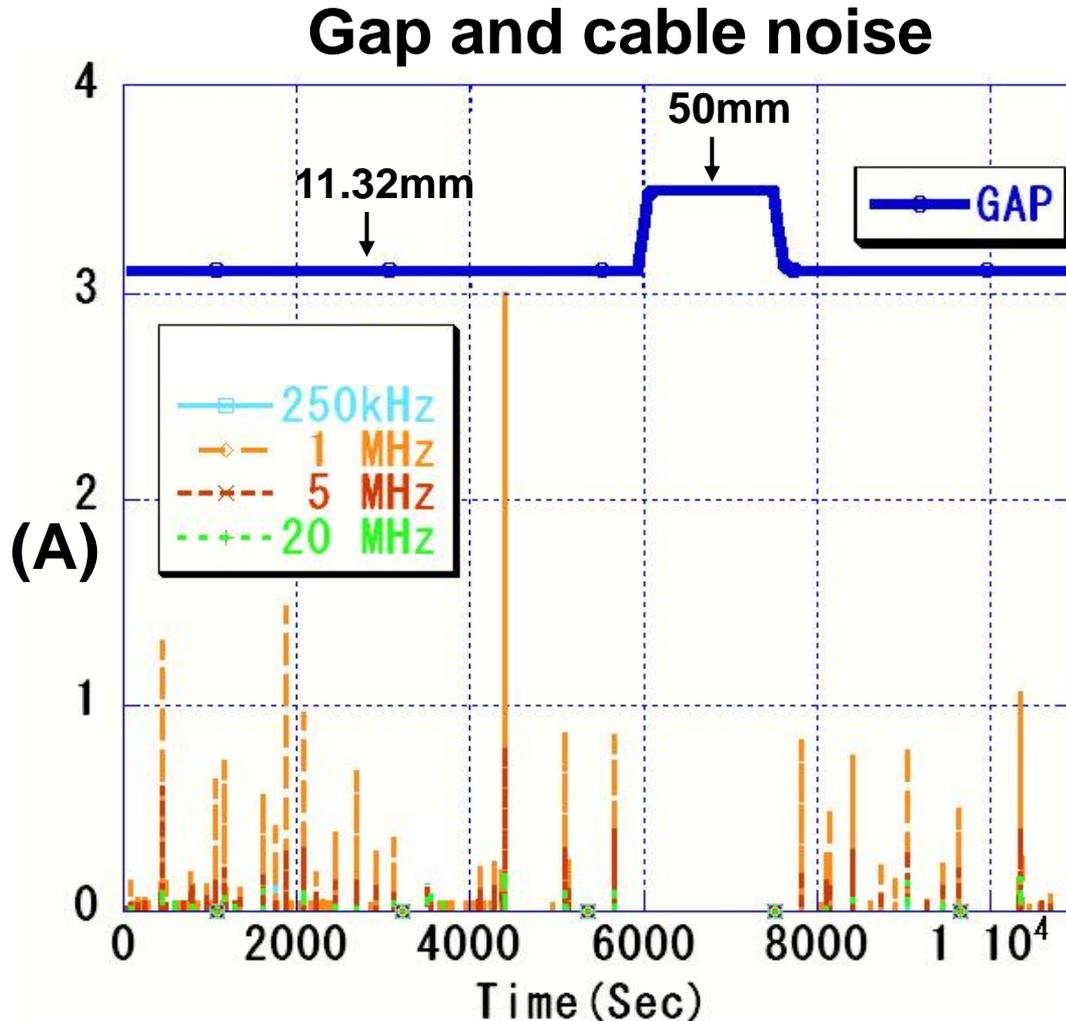
Correlation between noise and undulator gap

Low flux: no noise
High flux: high noise level

The noise is correlated with high X-ray flux.

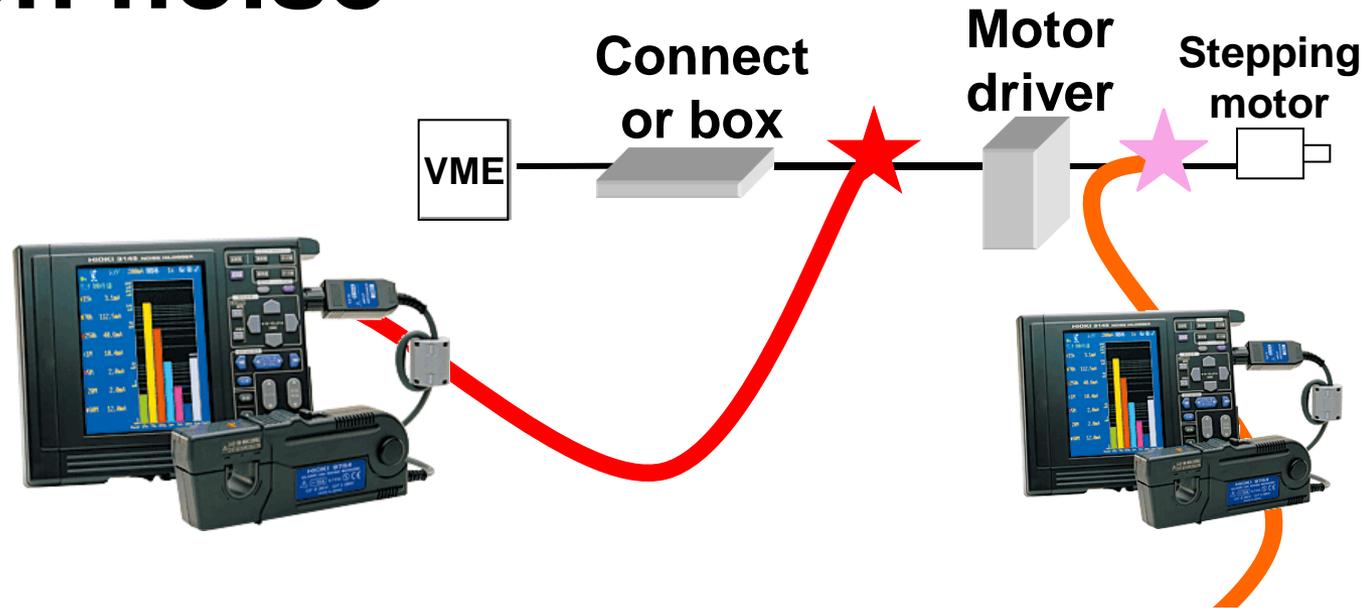
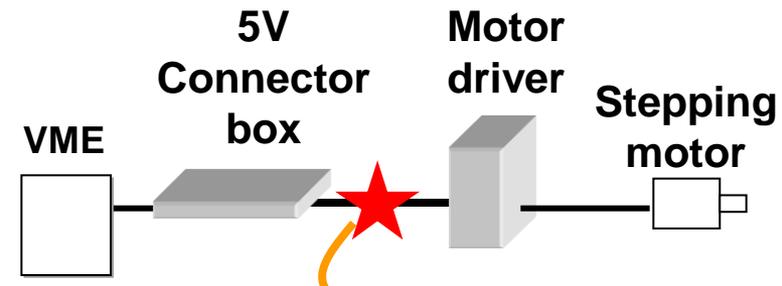
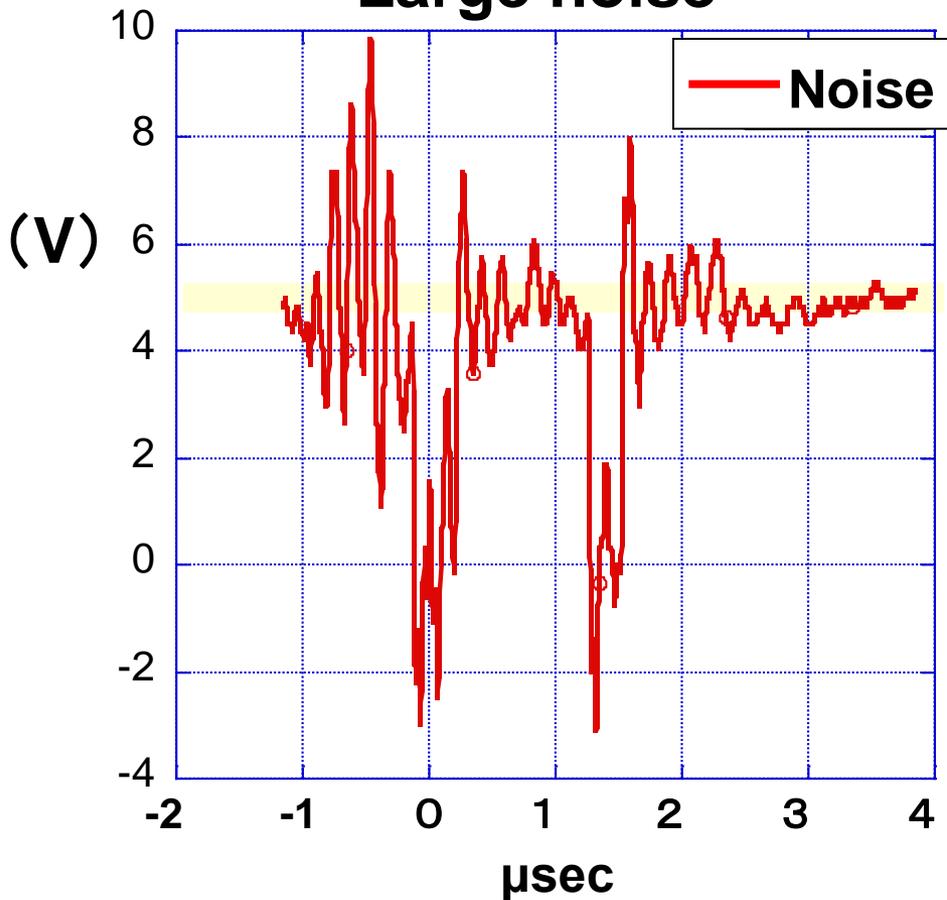
Correlation noise

When this noise occurred ,
noise (★) was found.

Large noise measured

Voltage of a motor control signal

Waveform : showering noise
Frequency: about 1 MHz
Amplitude: over 12V

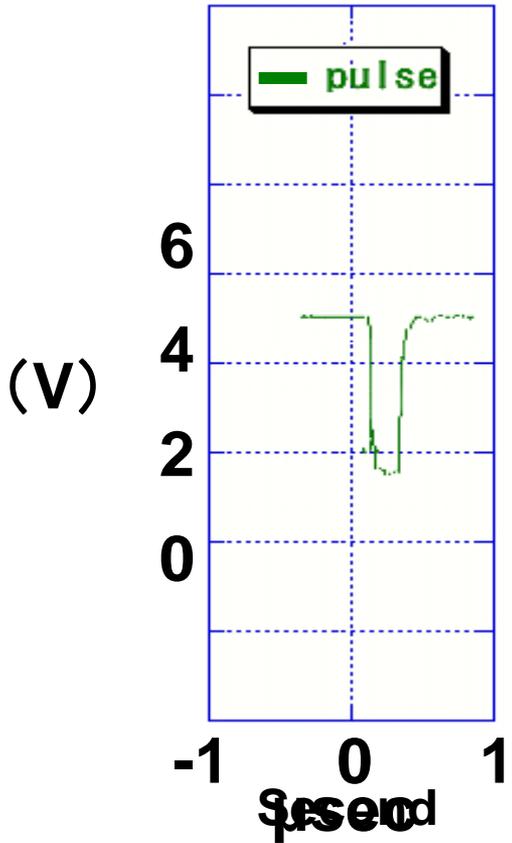
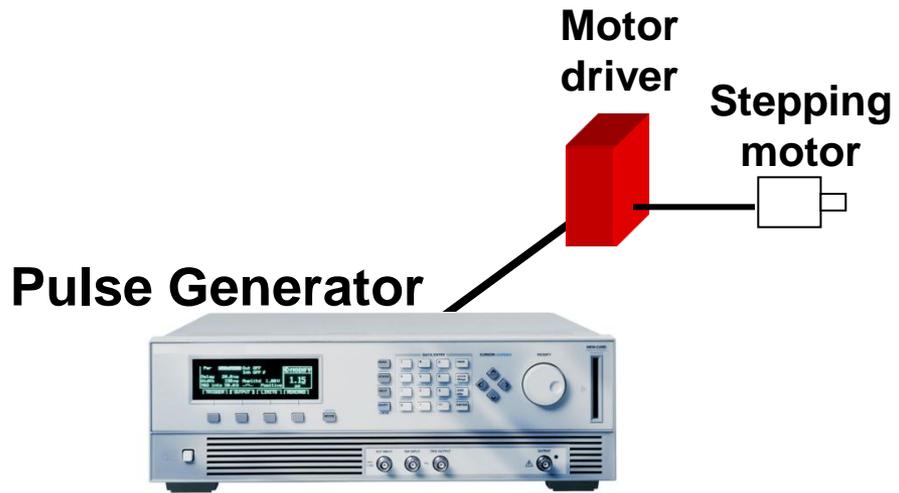
Measured minimum pulse

Motor driven by one minimum pulse

Pulse width: 216nsec
Voltage : 3.3V
