Study of Electrical Noise Induced by Synchrotron Radiation

JASRI/SPring-8

Problem: unstable X-ray intensity

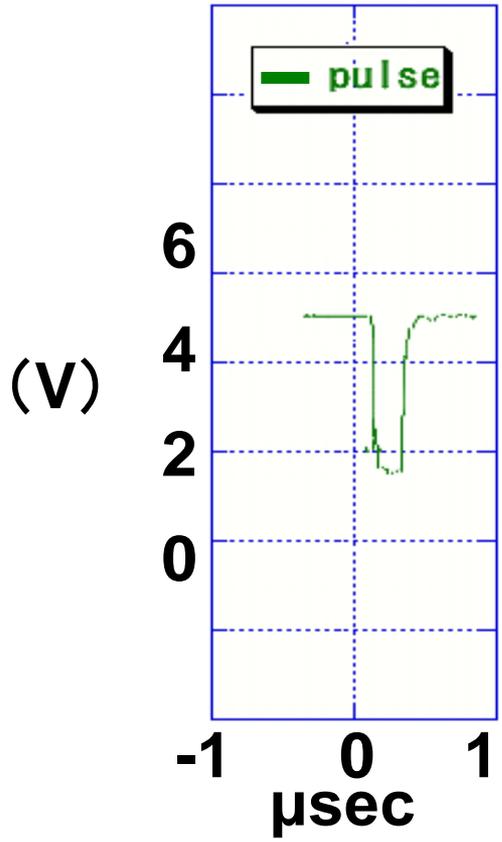
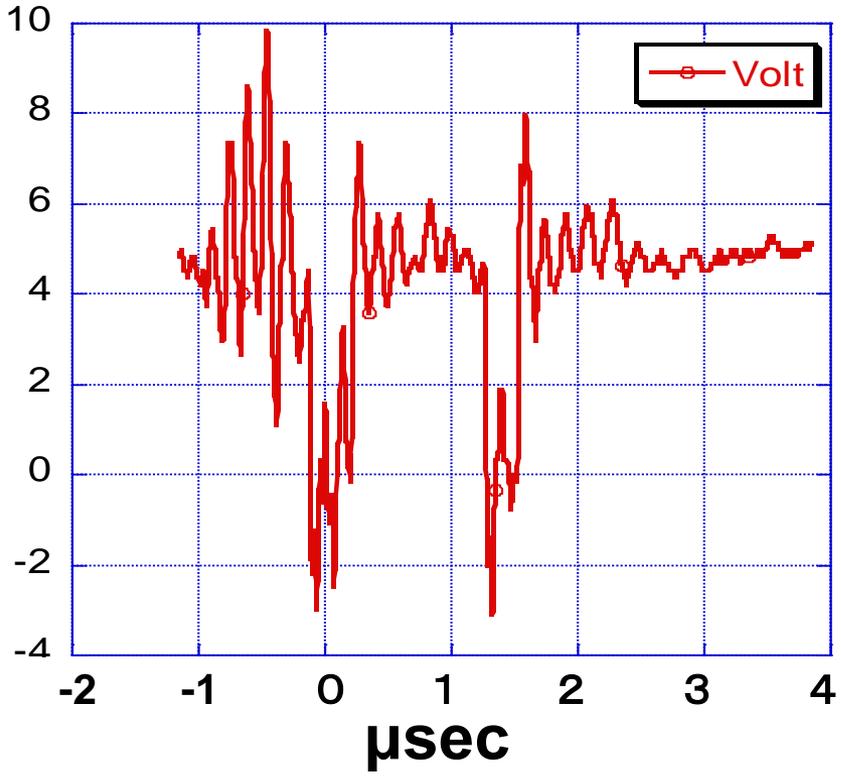
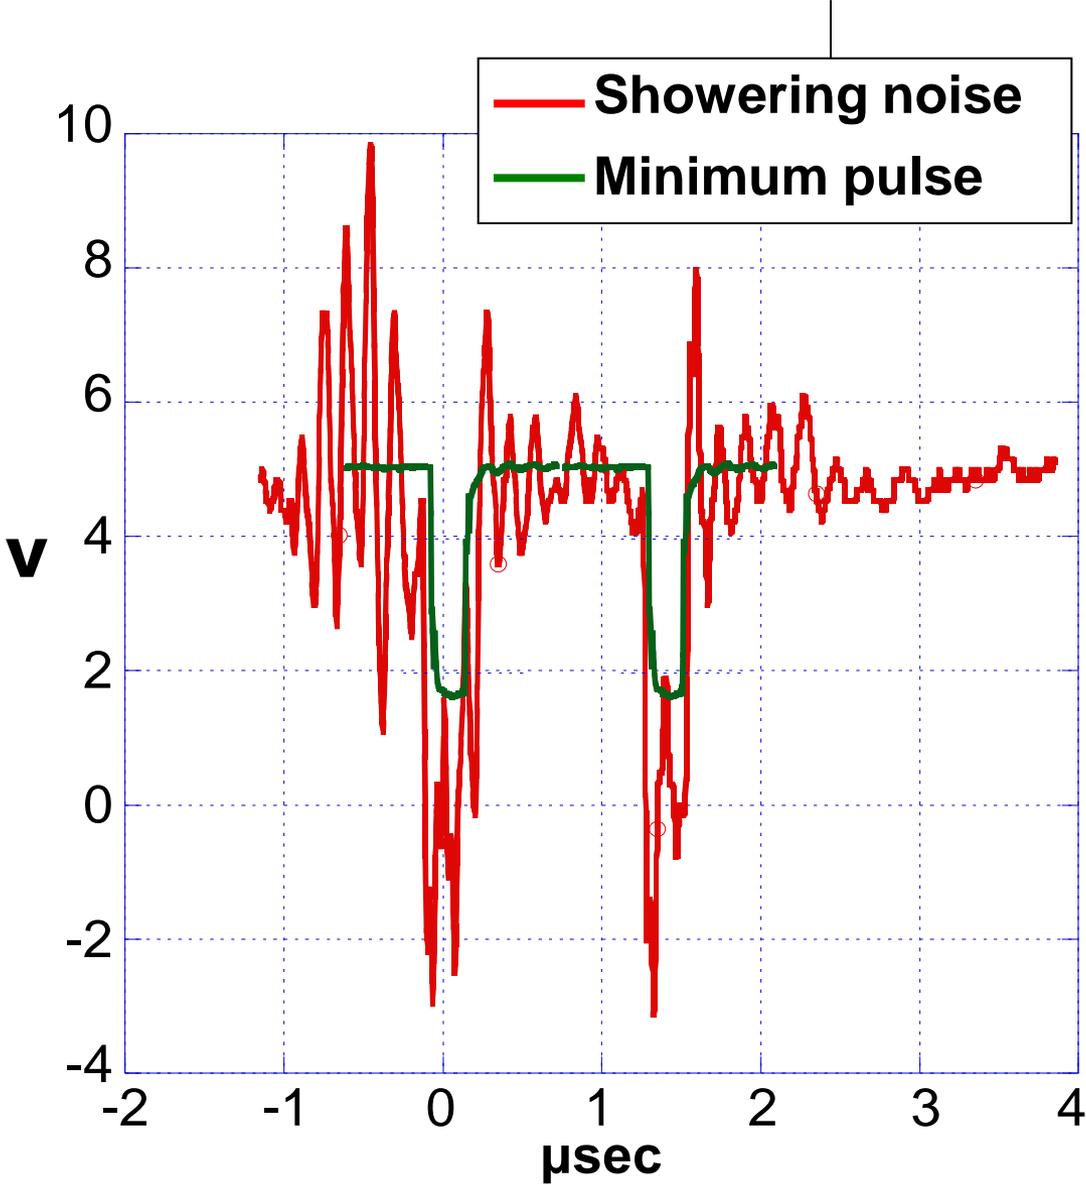
Comparison between showering noise and signal

showering noise

**Showering noise is over
Minimum pulse voltage.**

**Showering noise drive the
motor 2 pulses.**

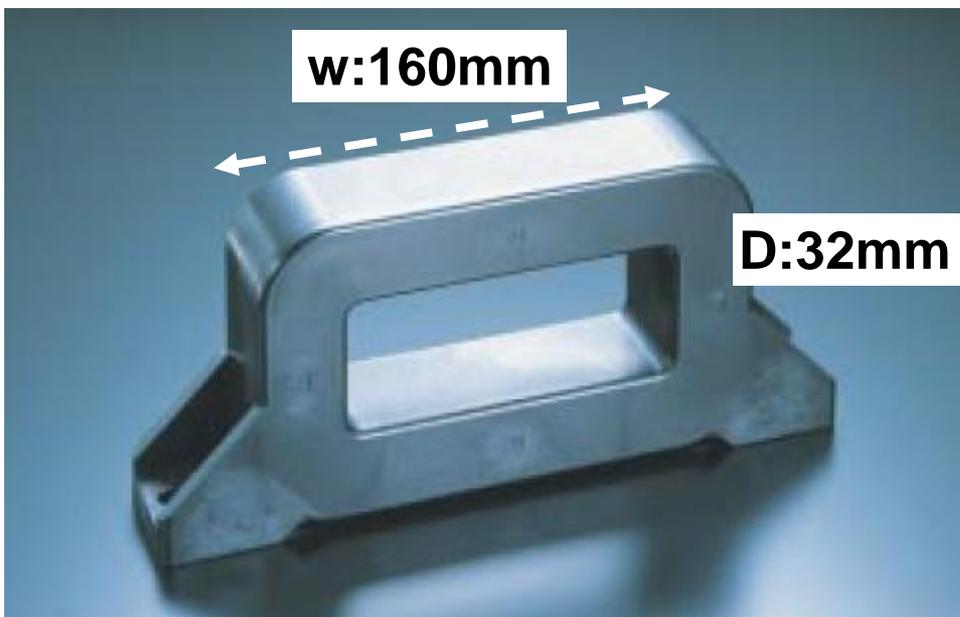
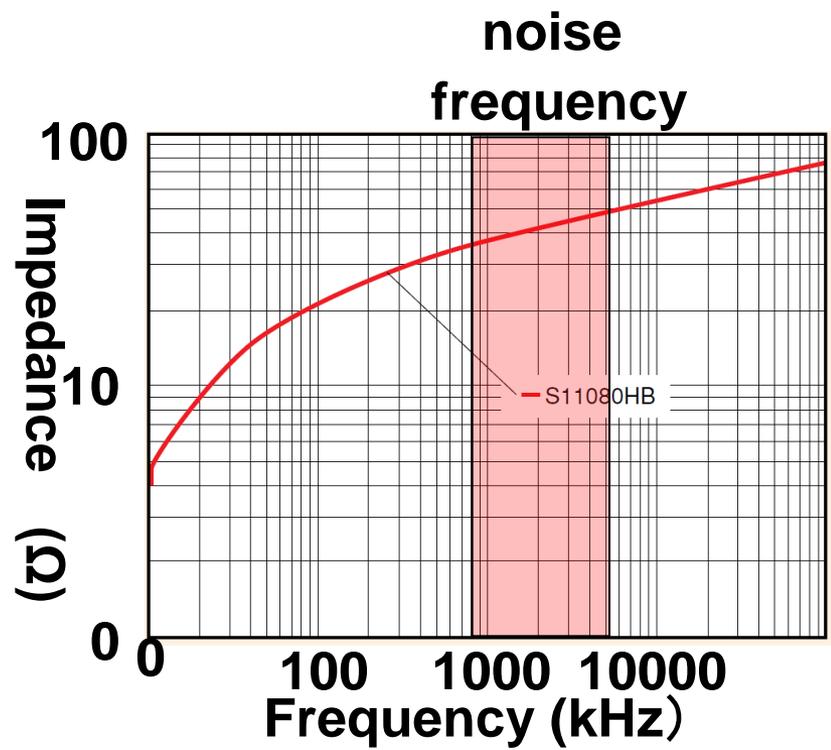
Ferrite core

model number: FT3KM S11080HB
quality of material : **FINEMET**
Hitachi metals

impedance character

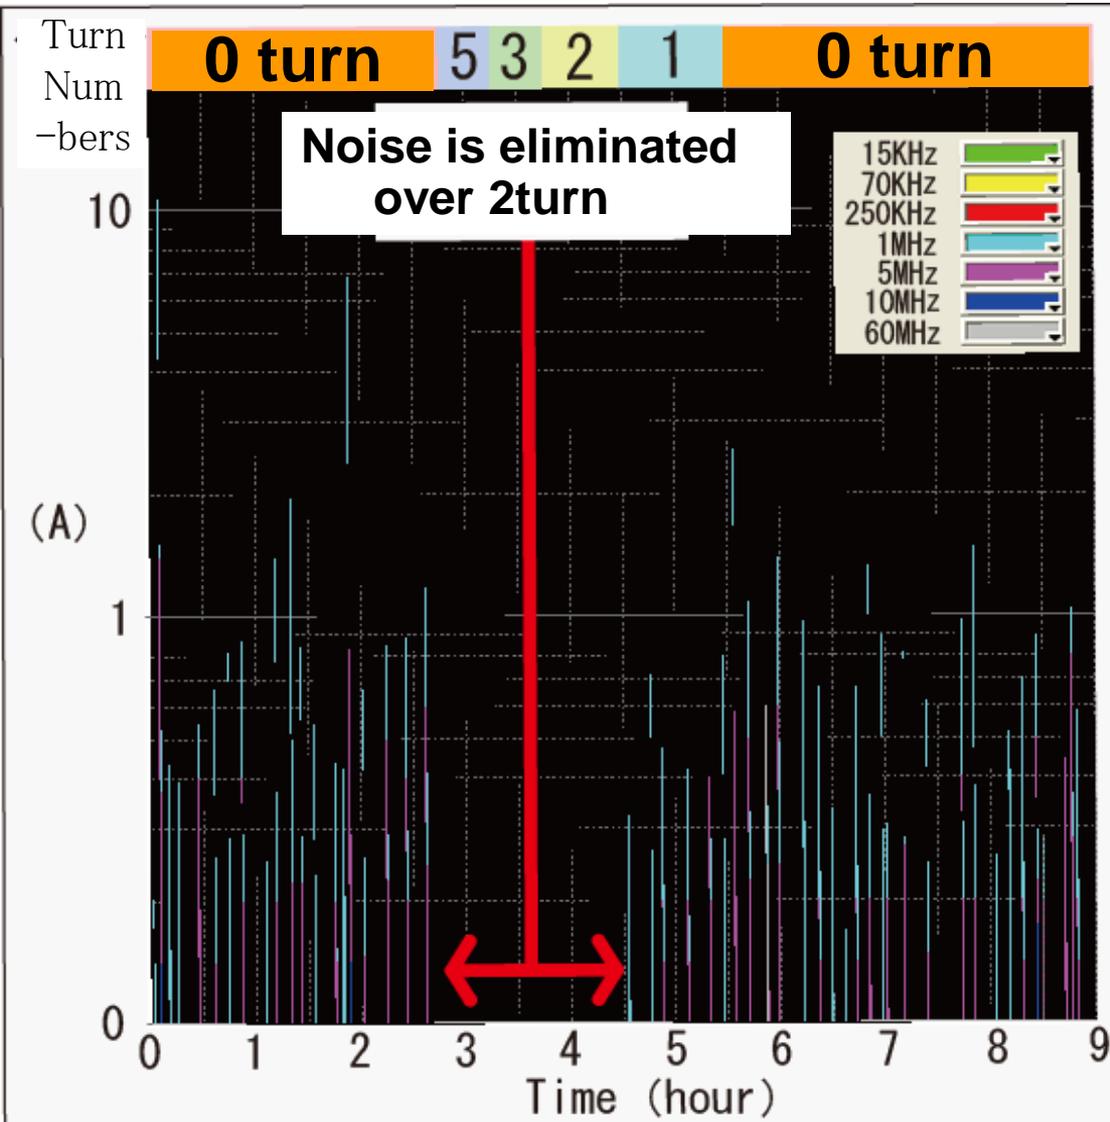
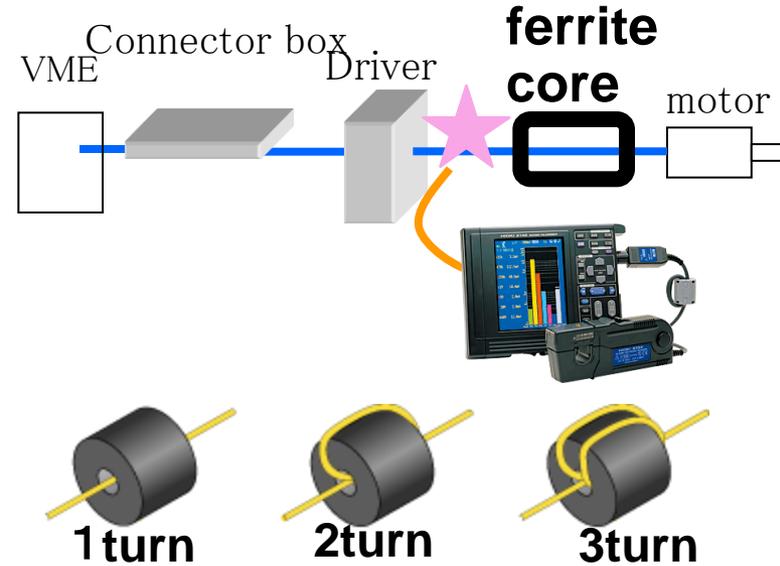
Prevent inrush electric noise into control system by using ferrite core

$$\text{Impedance} = \text{an Impedance} \times N^2$$

The noise was not dropped over 2 turns.

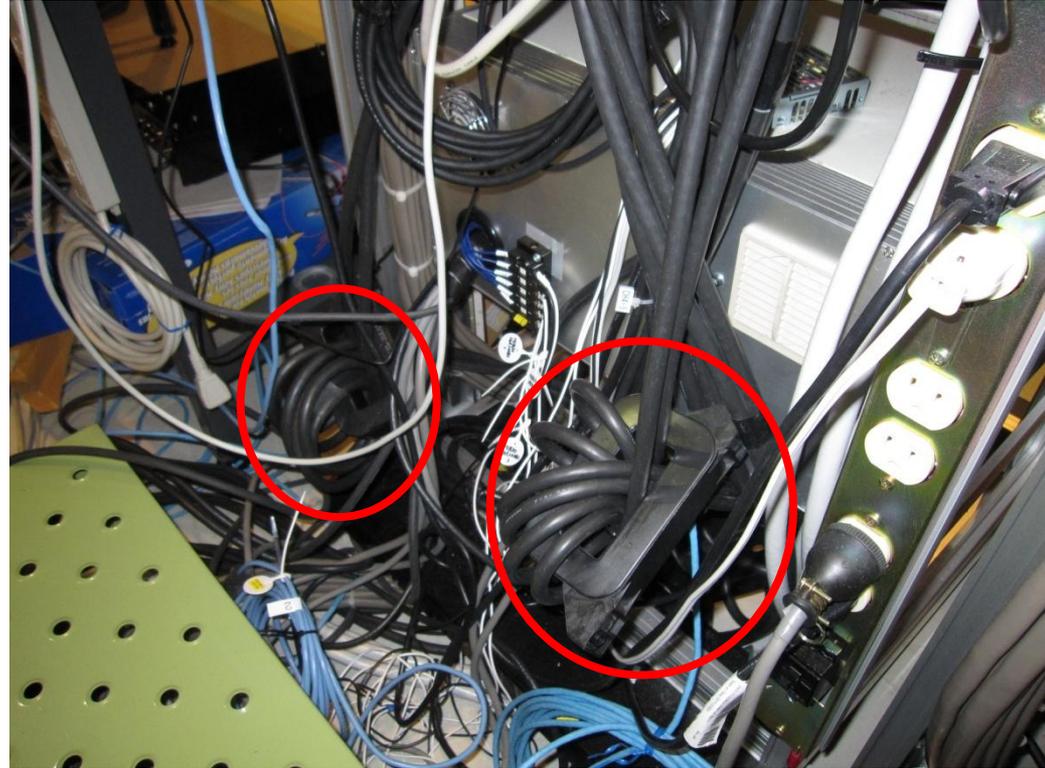
Installation Problems

- There are not enough space for core.
- Cable winding is difficult.

We searched the new core to install easily to existing cables

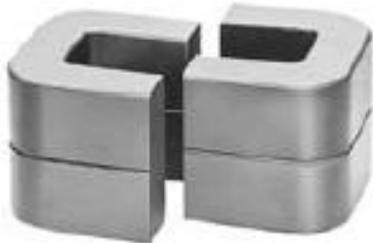
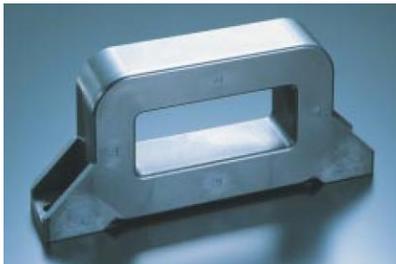
Ferrite core selection

**PE22
TDK**

**FINEMET
Hitachi metals**

Installation	easy	difficult
Impedance character	20Ω :1MHz:1turn	38Ω :1MHz:1turn
Noise reduction	Not-measure	2turn is enough
Total Impedance	20Ω × 8 piece=160Ω ≐	152Ω ← 38Ω × 2turn²

8 pieces of ferrite core clumps cables with 1 turn

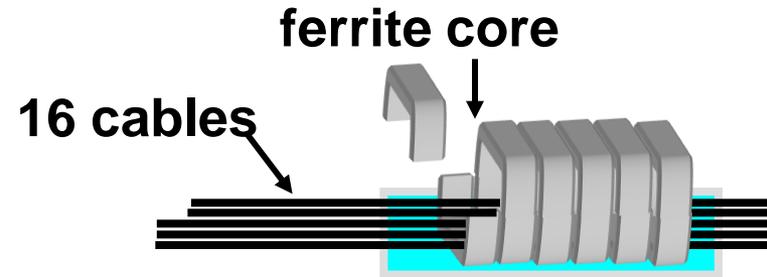
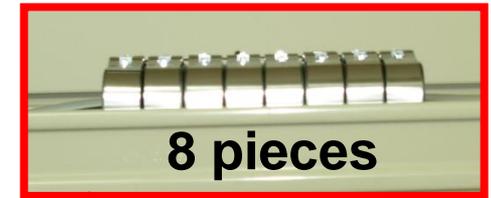
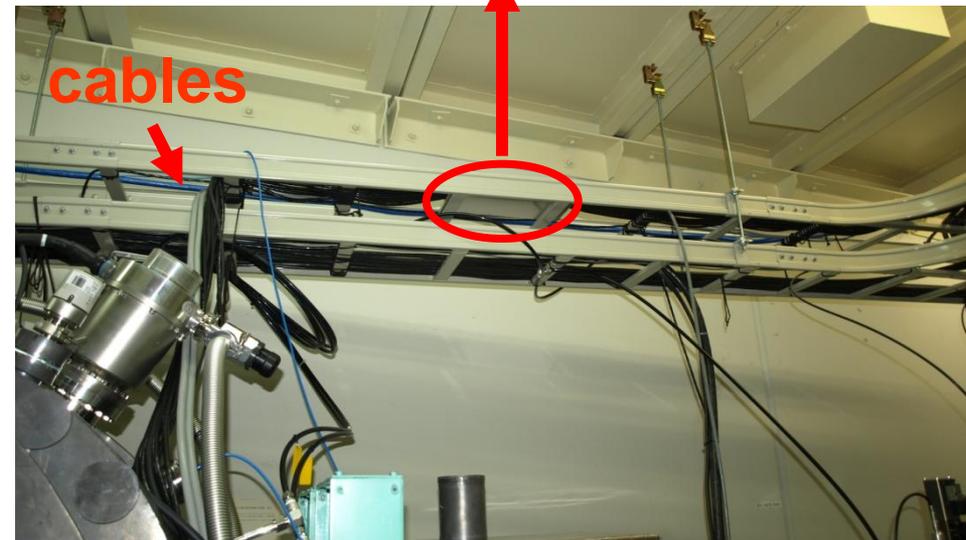
Installation of Ferrite core

- We can install the ferrite core, easily.
 - 8 cores clamped 16 cables.

bottom view

- NO noise.
- X-ray intensity stabilized.
