Operation management of superconducting RF cavity at

Elettra
P.Zupancich

Abstract

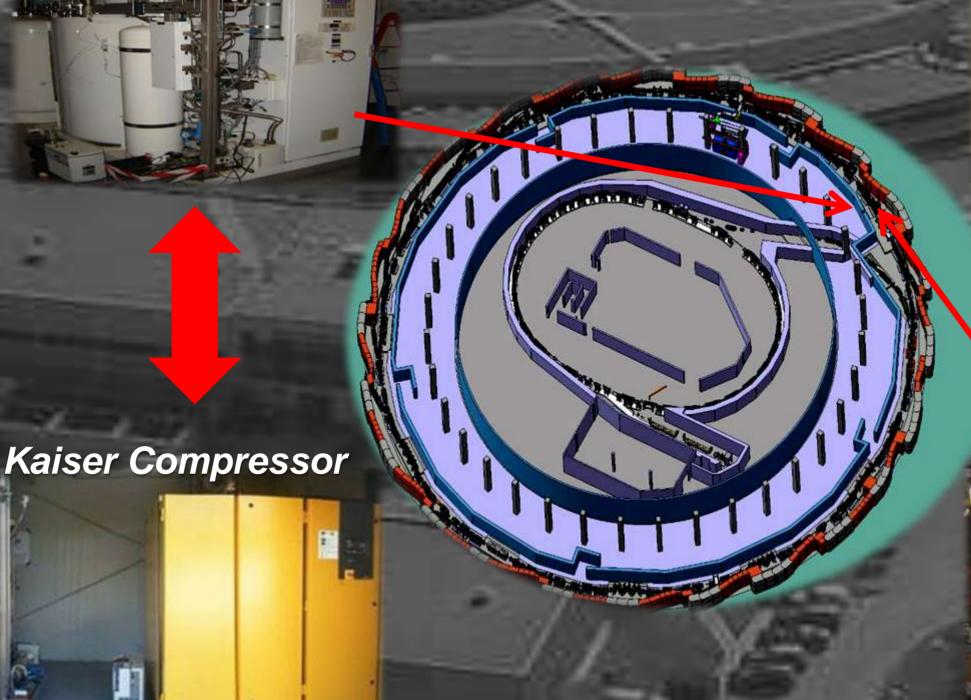
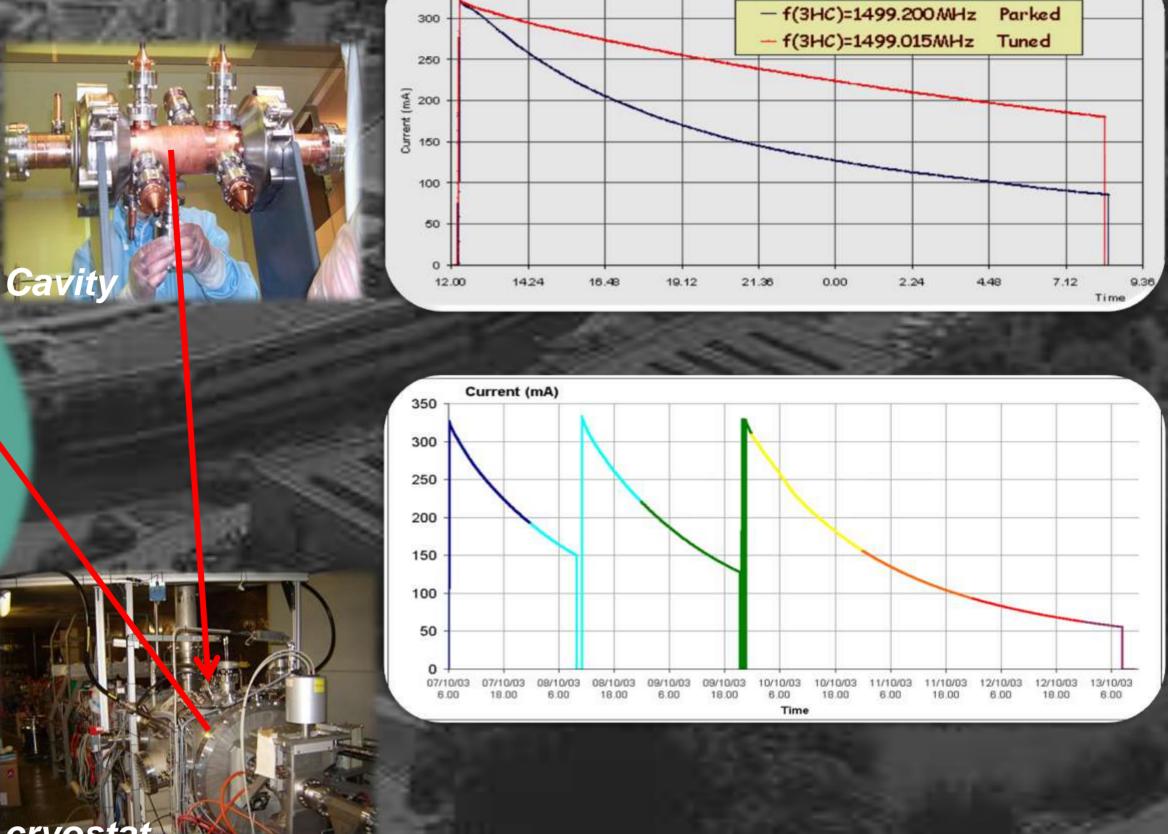
Before top-up injection with the new booster, the activation of the 3rd harmonic cavity allowed to inject in the ring each 2days instead of every day. Comparison between a typical day with 3HC tuned (beam longitudinally stable) and a day when it is parked (controlled longitudinal excitation).

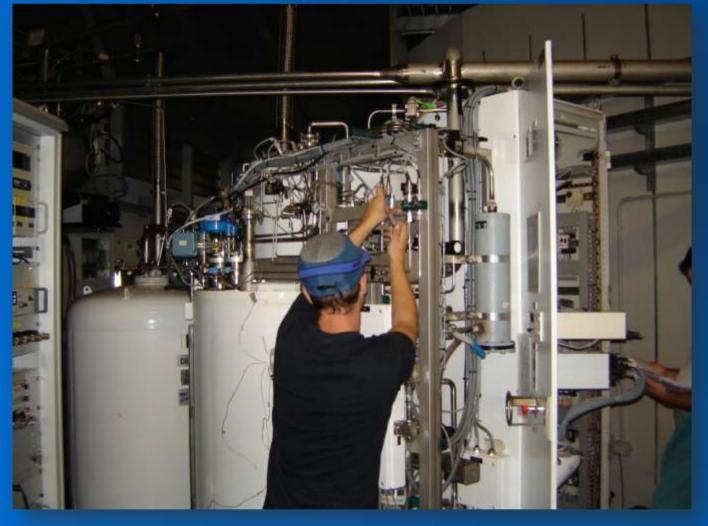
Air Liquide technician on Helial 1000 during the maintenance

The cryogenic plant (Helial 1000) needs an annual maintenance, which is provided by Air Liquide technicians. Operators follow the maintenance, giving support to all the activities. During the last shutdown they participated in the replacement of the screw compressor.

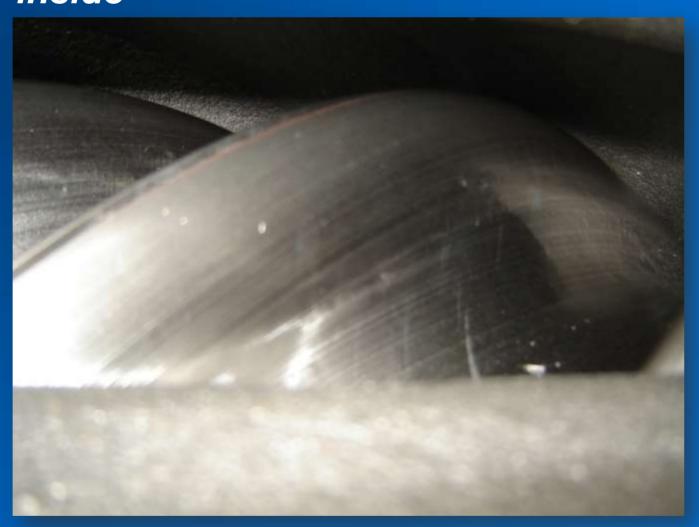
View of the screw compressor from the inside

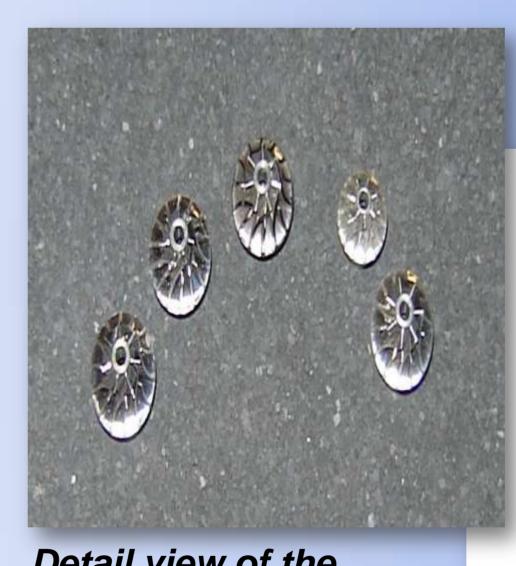
Cryogenic Turbine training

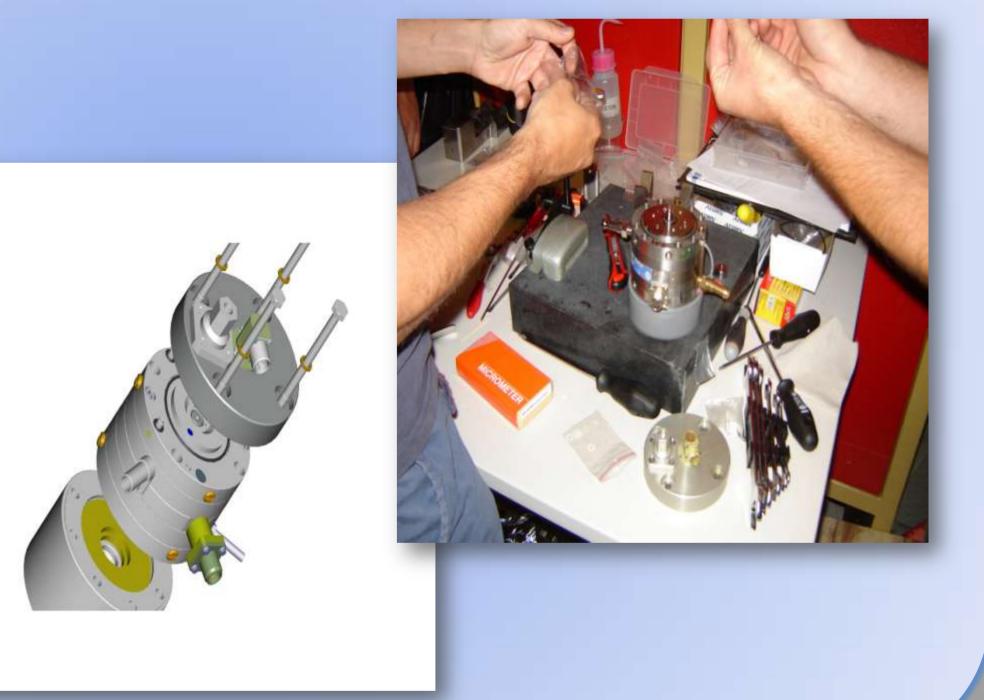
Detail view of the turbines during the course

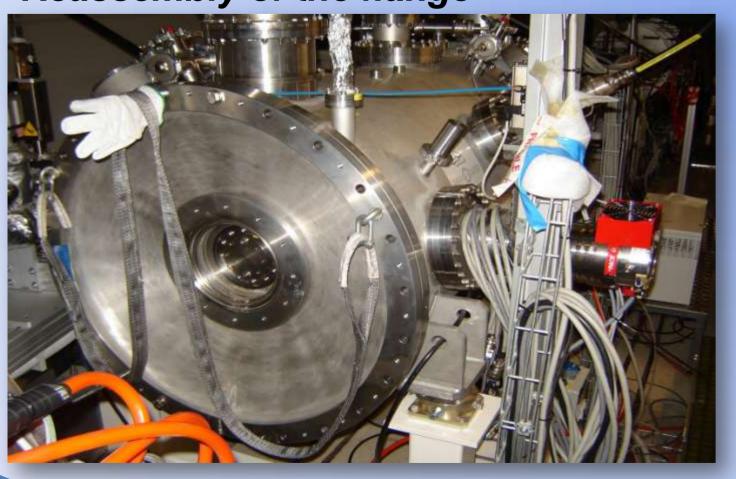
Reassembly of the flange

Last year a leak on the the cryostat vacuum insulation was detected and this leaded to a bad cryogenic efficiency. An important intervention was scheduled in the last shutdown, consisting in venting dry nitrogen in the cavity with a slow controlled flux, removing the main flange and fix the leak by a new TIG welding torch. The SC cavity did not suffer any pollution and it has been now operating.

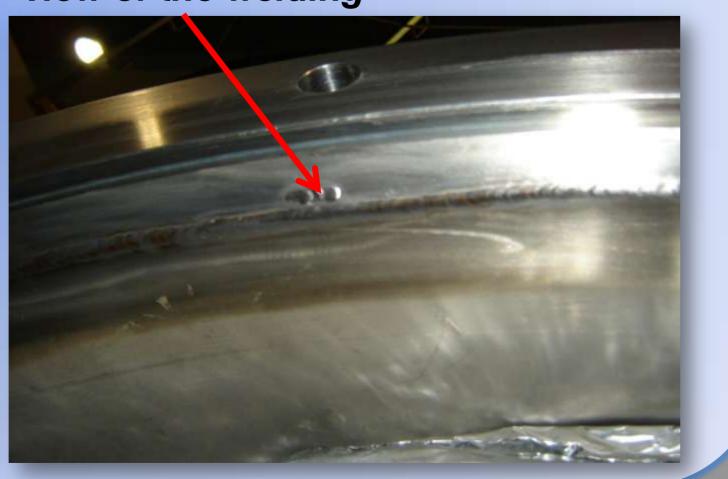
View of the welding

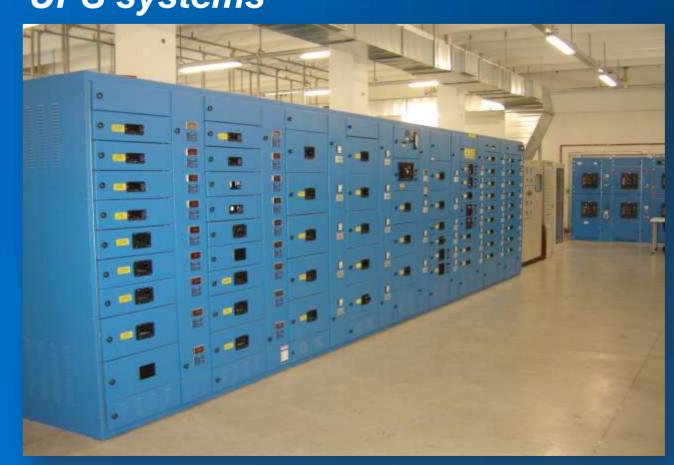
UPS systems

In 2011 we connected all the system of S3HC directly to the trigeneration plant (CHCP: Cogeneration of Heating, Cooling and Power). This unit was designed as a no-break system and to sustain the UPS electric loads (250KW only for the main compressor) during micro-interruptions or interruptions of the external electric power supply. This was very useful for system reliability, faults due to voltage sags are almost forgotten!

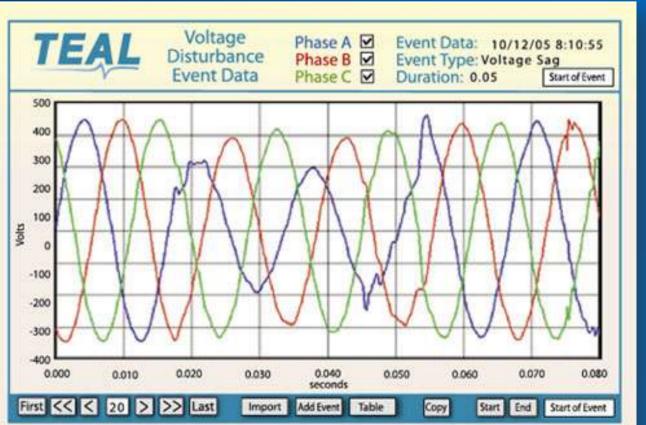
Example of voltage sags
