High Risk Maintenance Project

at the LBNL 88-Inch Cyclotron

Jim Morel

April 15, 2010

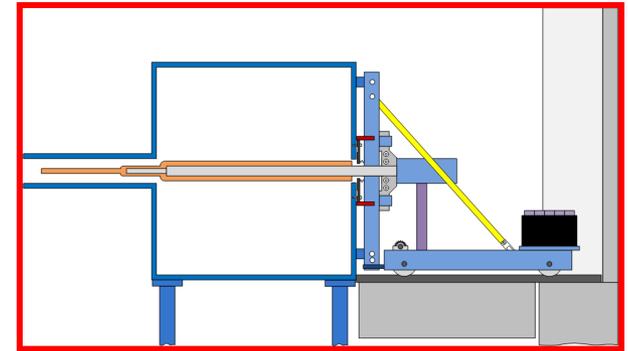
- The RF system had sparking problems and we had vacuum problems associated with high RF power.
 - We investigated and found the grounding strips had not remained attached and were overheated.
 - We also found a screwdriver had been left in the RF tank.
- The grounding strips were re-attached using appropriate material and the screwdriver was removed.
- Lesson Learned
 - How to attach the grounding strips.
 - We needed better management of tools.

- The Dee was reattached to the RF tank.
- Damaged grounding strips were replaced and all strips were re-attached.
- The alignment of the Dee was verified.
- The infrastructure connections were reinstalled.
- The Cyclotron was sealed and it pumped down easily.
- A standard beam was tuned out of the Cyclotron..we were able to accelerate particles.
- The Dee cart was removed form the Vault.
