SLAC National Accelerator Lab.

# Recovery from the Fire Accident at PEFP

2012. 8. 9

Bum-Sik Park

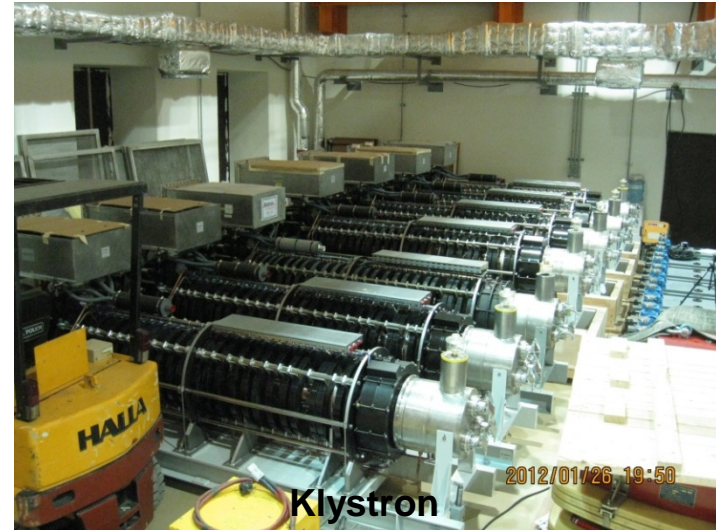
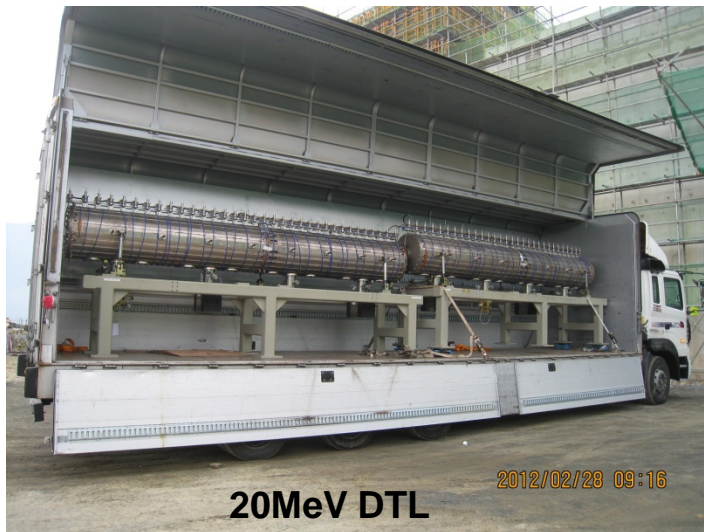
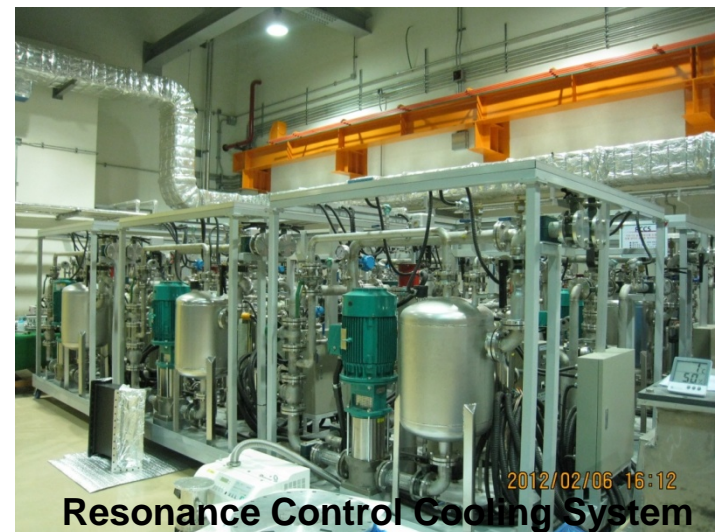
# 20MeV Linac Disassembly and Transportation

- 20MeV linac was operated and supplied proton beam to users at KAERI site until November 2011
- Disassembly of 20MeV linac : January 2012
- Installation of 20MeV linac at project site : February 2012
